DUE DILIGENCE PROPERTY INSPECTIONS

OFFICIAL PROPERTY INSPECTION REPORT(*)

1234 Main Street
Rocky Mount, NC 27803

Buyer Name
05/08/2023 9:00AM

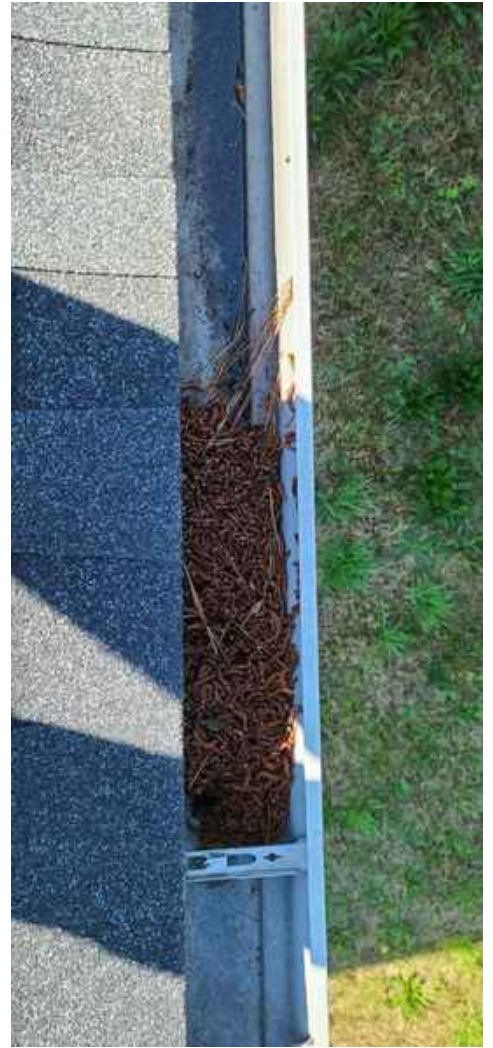
There was visible debris clogging the gutter's drain hole, which can allow the gutter to overflow. Overflowing gutters could cause decay, especially to the wood behind the gutters. Overflowing gutters can also cause moisture problems with the foundation/crawl space. The gutters need to be repaired by a qualified contractor.

Contact a qualified gutter contractor

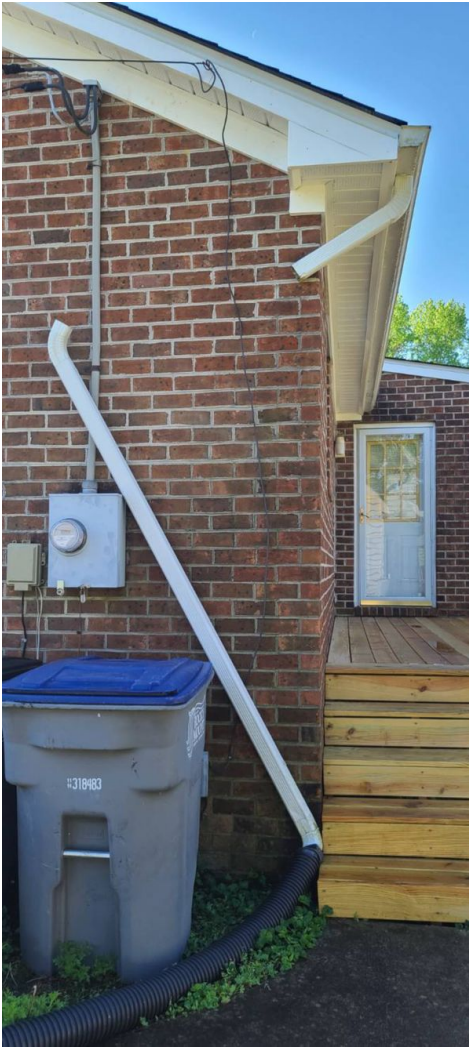
2.2.2 Drainage System

NOT CONNECTED TO GUTTER

The downspout on the location(s) listed above of the house was not properly connected to the gutter. This could allow water to flow out of the gutter and down the wall. The downspout(s) need to be repaired by a qualified contractor.

Contact a qualified gutter contractor

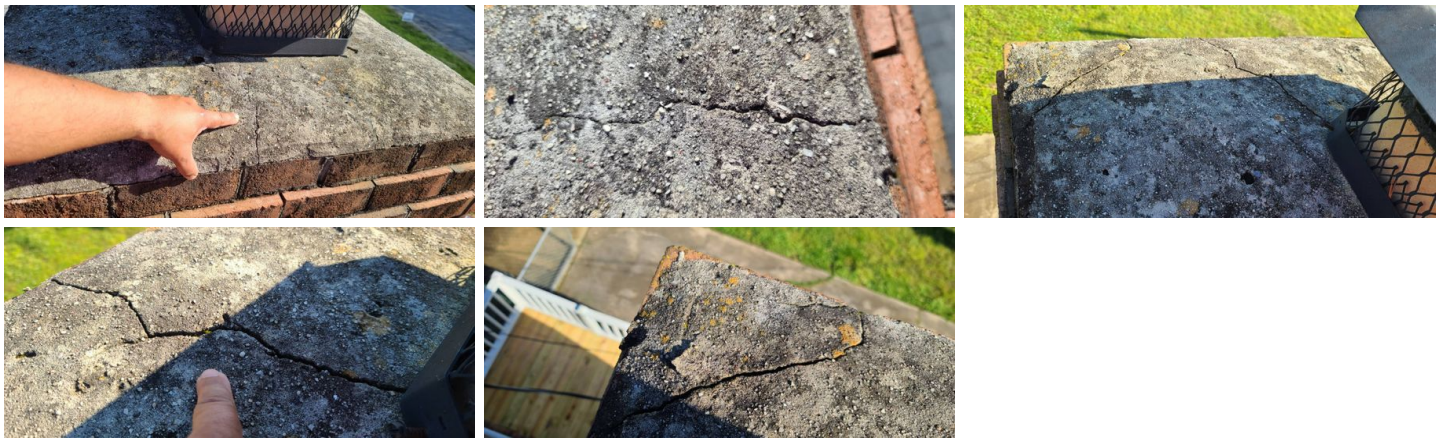
CRACKS IN CROWN

There were cracks in the crown on top of the masonry chimney. The cracks can allow water infiltration. The cracks need to be repaired by a qualified contractor.

Contact a qualified chimney contractor.

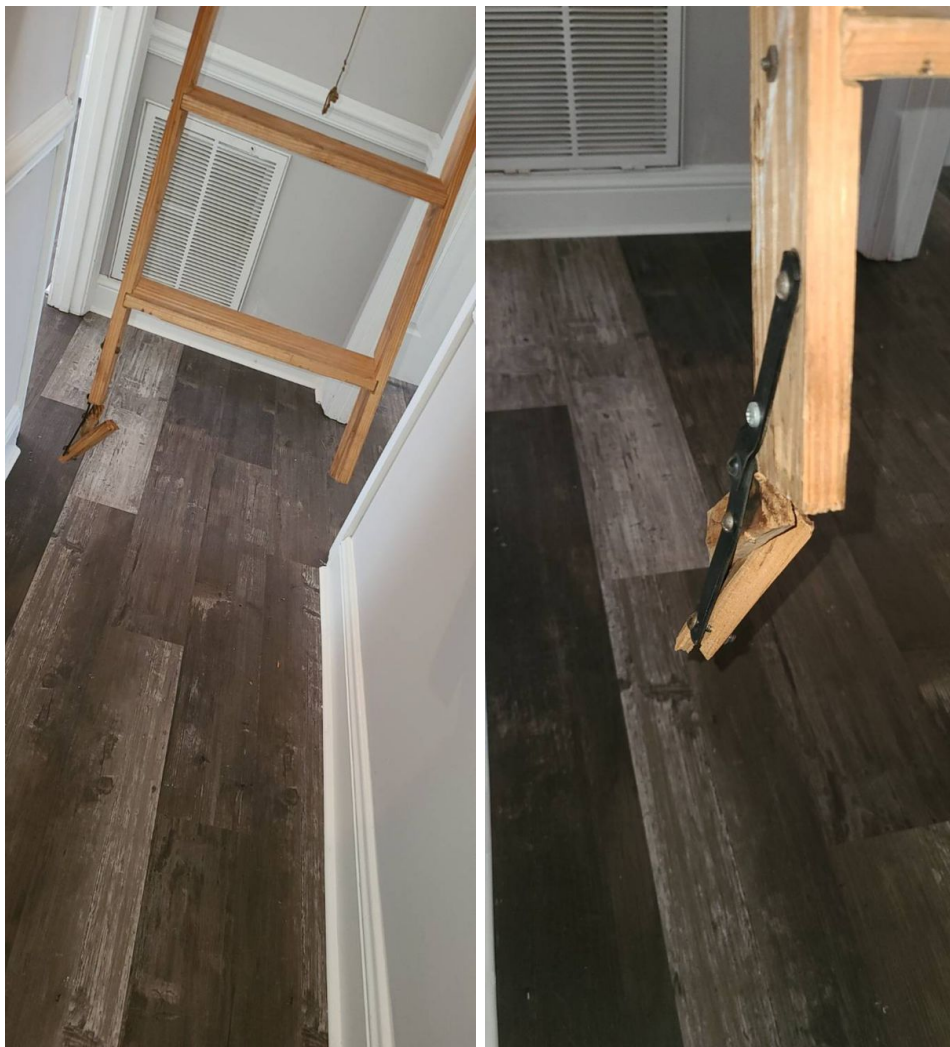
2.6.1 Attic Access

PDS LENGTH

The pull-down stairs were broken and unable to rest on the floor or be used to access the attic because the lower portion was missing. The attic pull-down stair needs to be repaired by a qualified professional.

Contact a qualified professional.

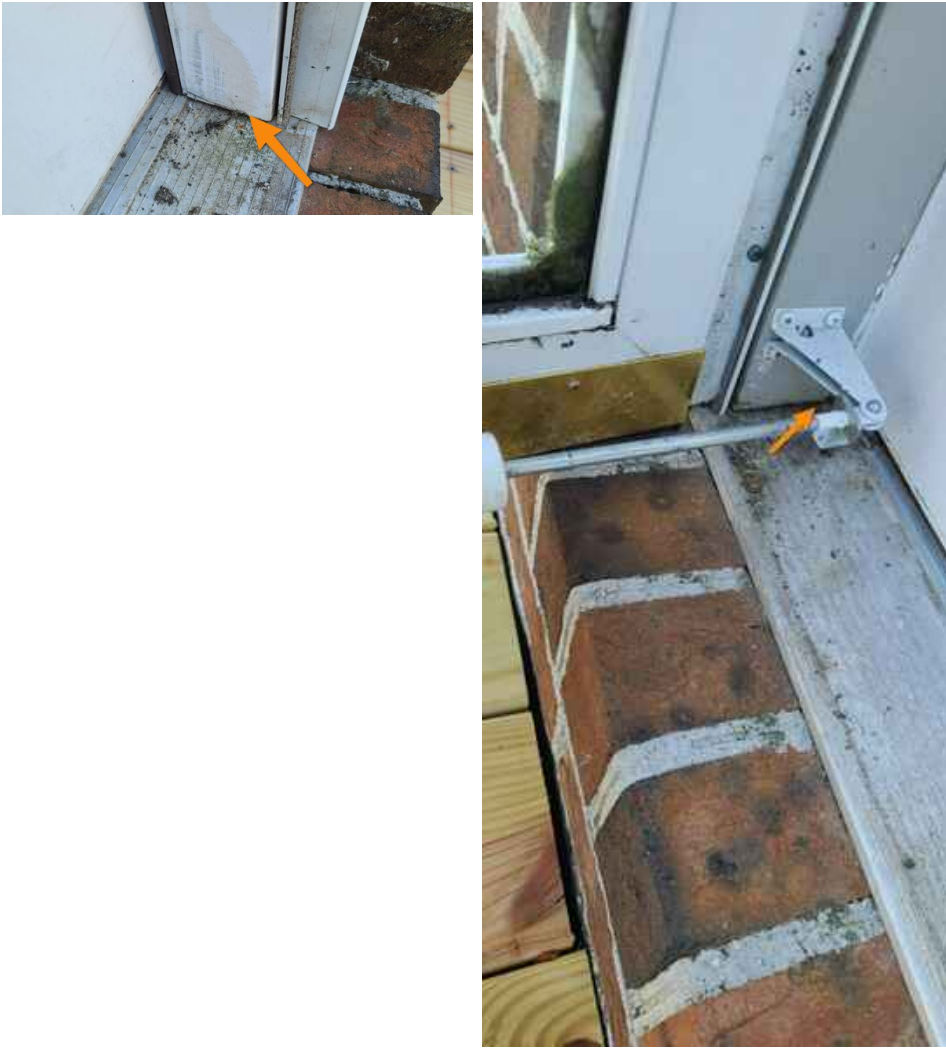
3.6.2 Entryway Doors

DOOR WITH NO SUPPORT UNDER THE THRESHOLD

There was no support under the outside edge of the threshold on the exterior door in the location(s) listed above. This can allow the threshold to move when it is stepped on. Movement in the threshold can allow it to be damaged. The door(s) need to be repaired by a qualified contractor.

Contact a qualified door repair/installation contractor.

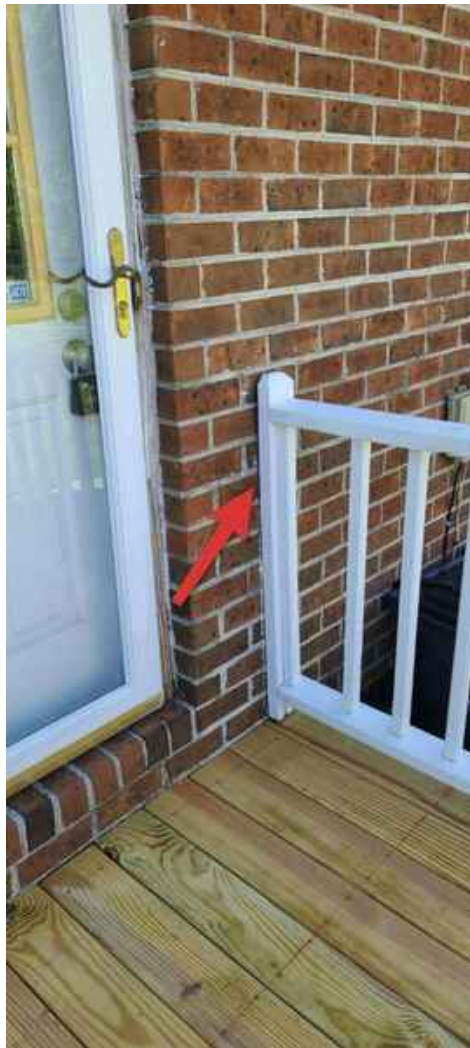
3.8.2 Porch/Stoop

CRACKS IN MORTAR ON STEPS

There were cracks in the mortar in the masonry porch steps in the location listed above. The cracks can allow water infiltration, which could cause problems over the years. This area in the crawl space is very wet. The cracks need to be repaired by a qualified contractor.

Contact a qualified masonry professional.

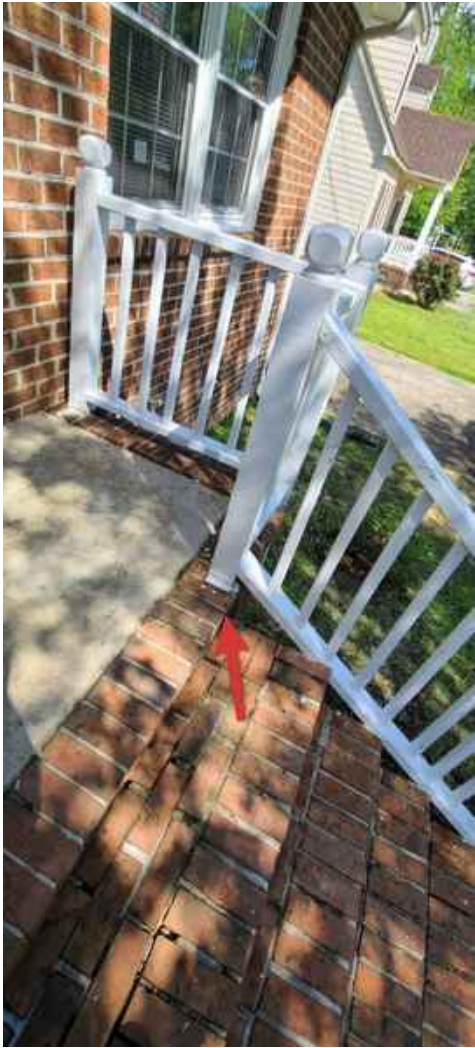
3.9.2 Steps/Rails

The steps on the location(s) listed above of the house were not level. The treads on the steps sloped down, which creates a tripping/falling hazard. The steps need to be repaired/replaced by a qualified contractor.

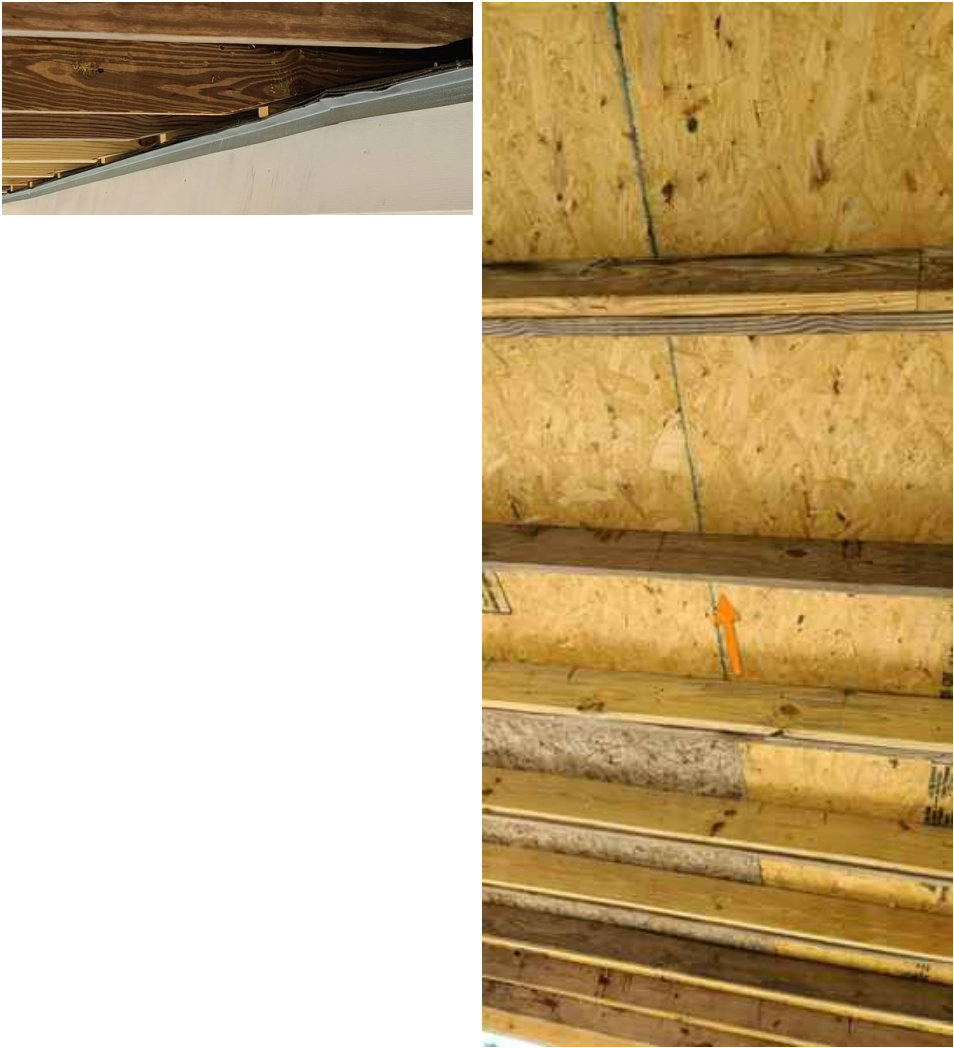
Rafter is not doubled—missing rafter.

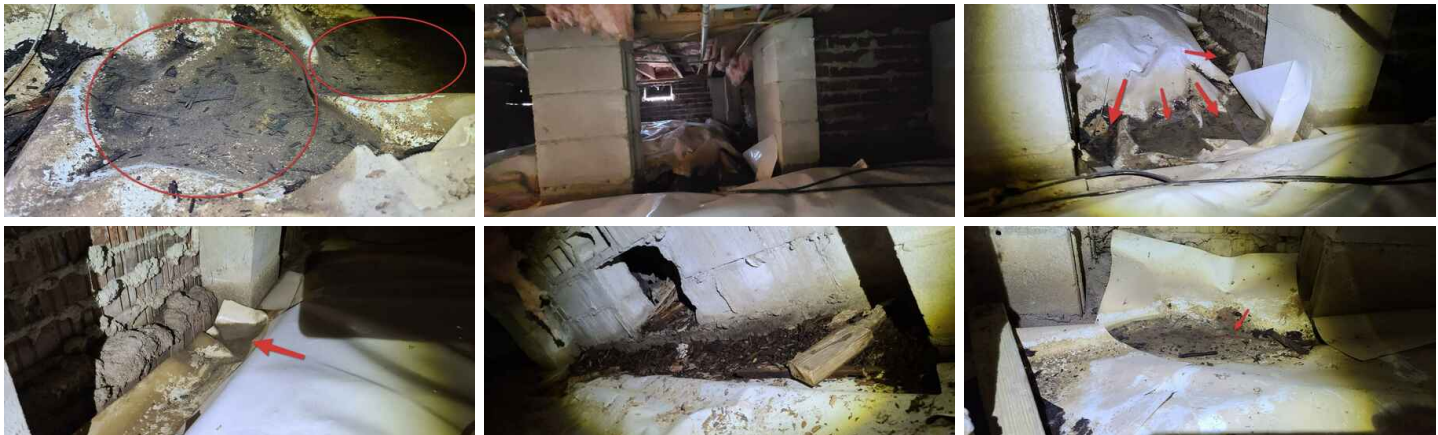
This is the wall behind the front steps. Standing water, wood debris, and cellulose material are in the trench and cavity. This may promote termite activity and other wood-destroying organisms such as fungus and mold.
