DUE DILIGENCE PROPERTY INSPECTIONS

OFFICIAL PROPERTY INSPECTION REPORT(*)

1234 Main Street
Rocky Mount, NC 27803

Buyer Name
05/08/2023 9:00AM

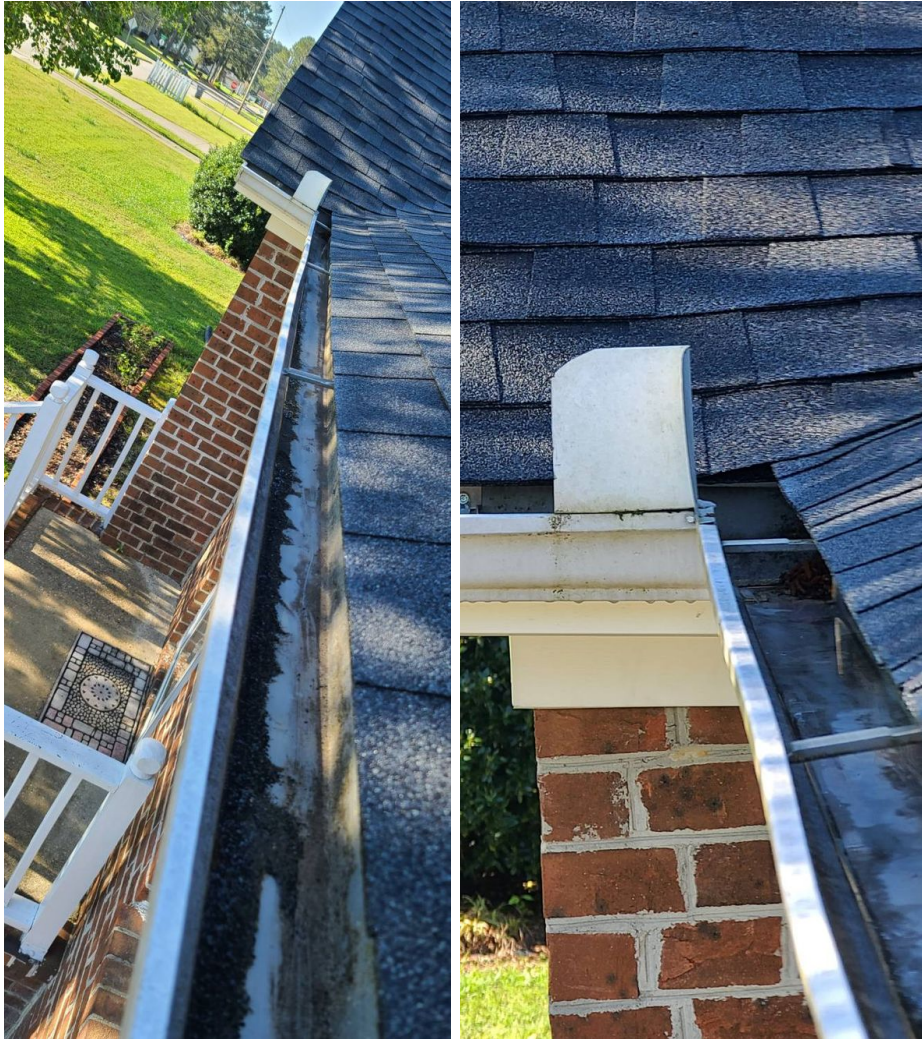
Drainage System: Diverters

Noted rain diverters installed over doors/porches/steps. Diverters are used to divert water around that area when it is raining.

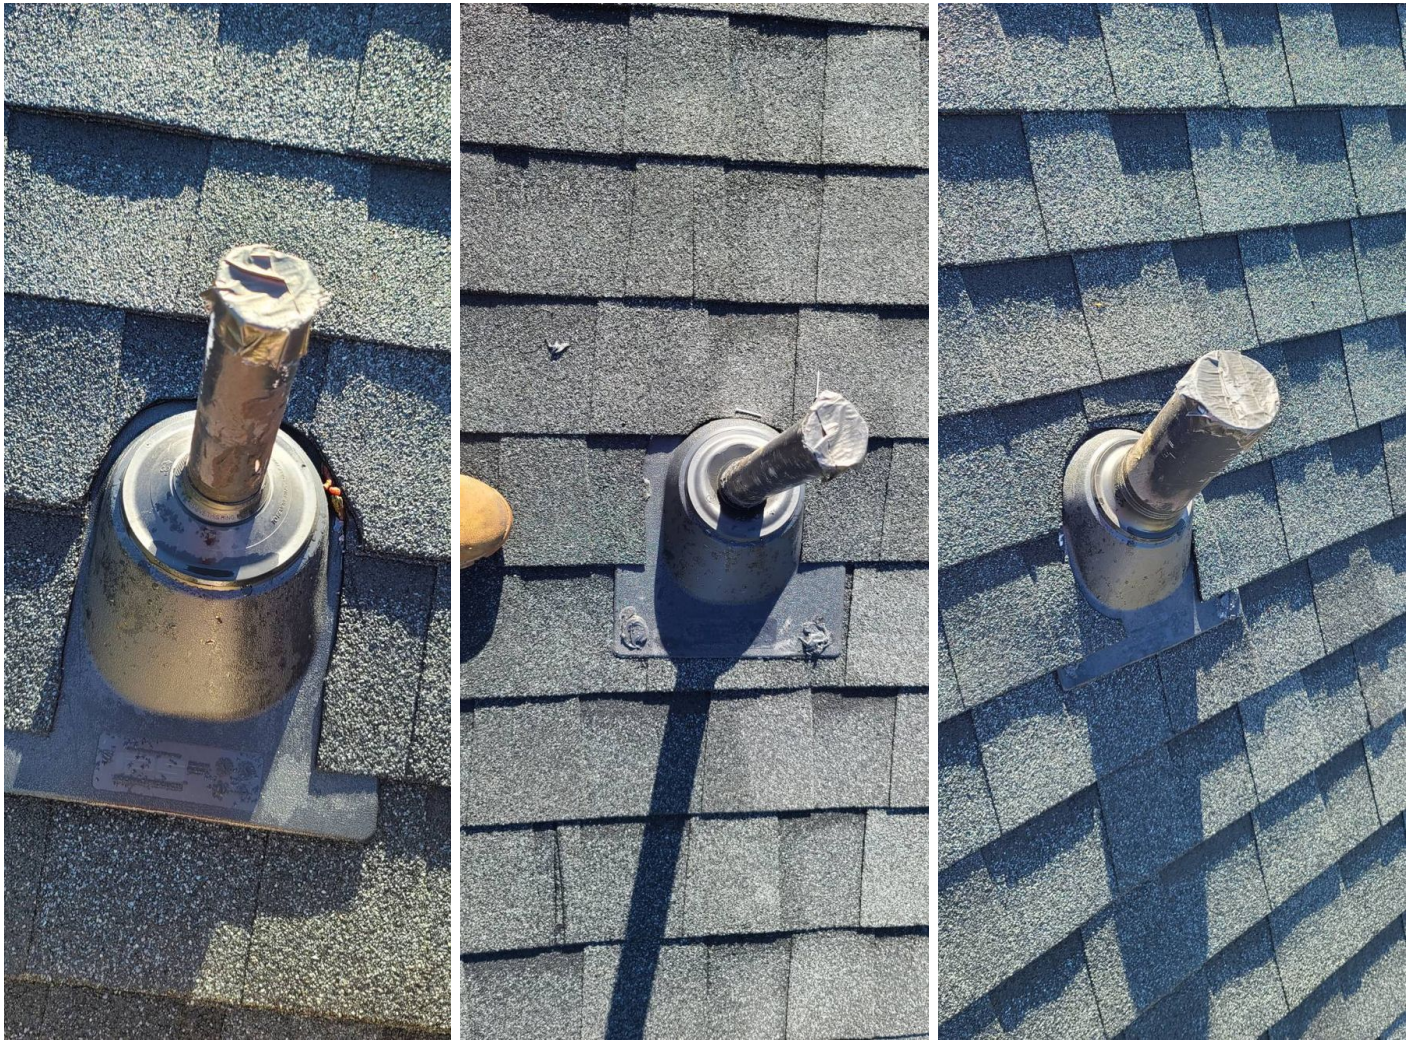
Roof Penetrations: Multi pipe boot

Noted boot(s) installed at roof penetrations that appeared to be adjustable to the penetration size. The seal on the boot can be torn off to match the size of the penetration. There was a visible seal at the penetration and no visible problems in the attic at the penetrations.

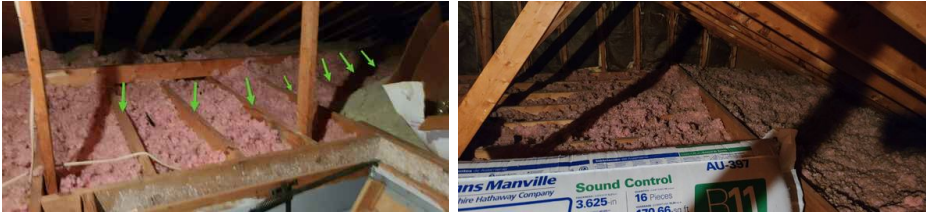
Roof Ventilation: Baffles not needed

Noted the construction method created a gap between the insulation and the soffit vents. There were no baffles needed in the attic.

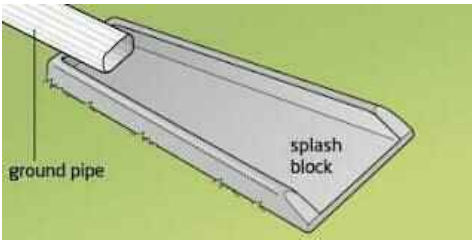
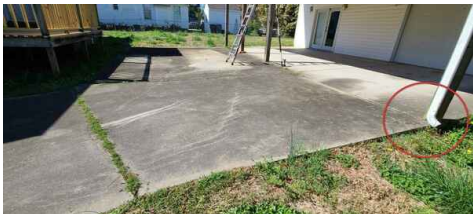
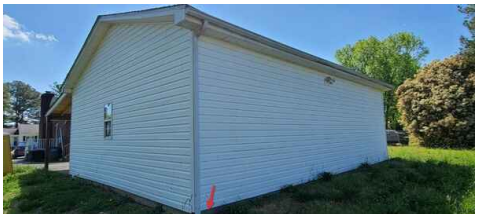
There were no splash blocks at the bottom of the downspout in the location(s) listed above. The water had dug a hole in the ground under the downspout, which can retain water against the foundation. The hole(s) need to be repaired by a qualified contractor and splash block(s) need to be installed.

Recommended DIY Project

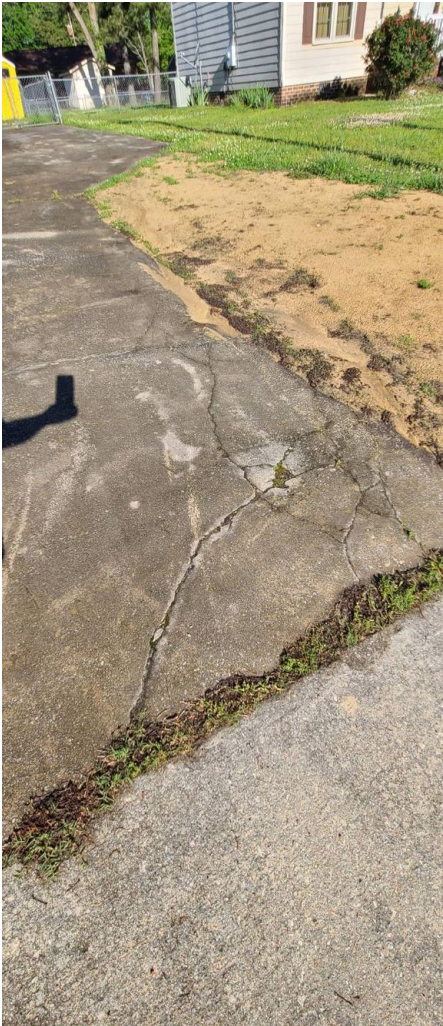
Driveway: Typical cracks

Noted typical cracks in the driveway.

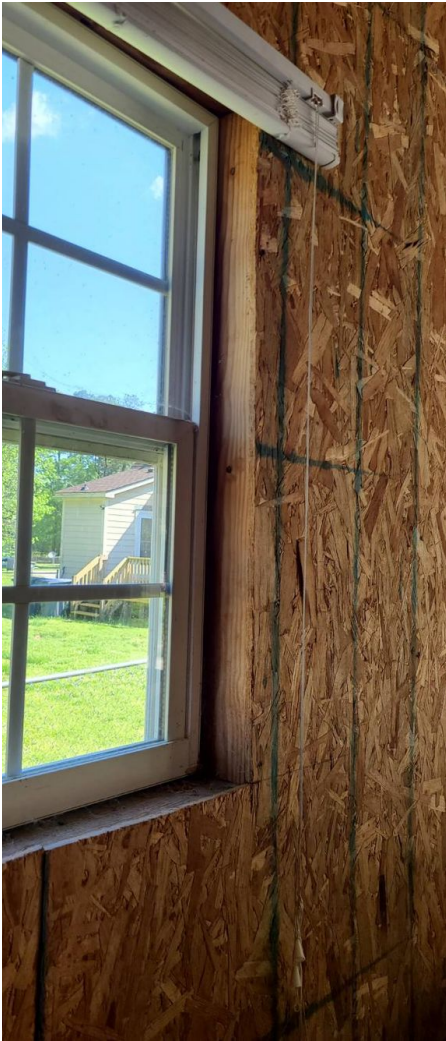
The garage wall structure was partially visible at the window framing.

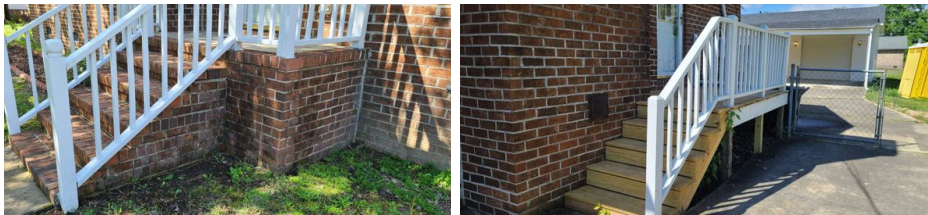
Porch/Stoop: Full view - perimeter

Noted the area under the porch was viewed from the perimeter. There was full view under the porch.

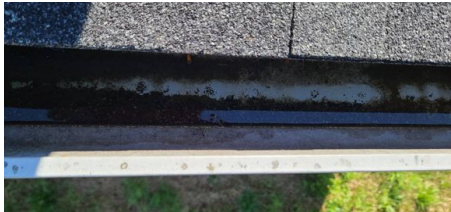
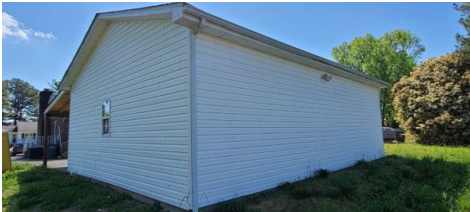
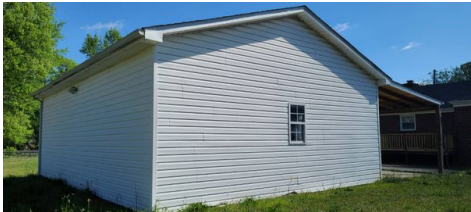
Debris in gutter needs to be monitored and cleaned regularly to prevent drainage problems.

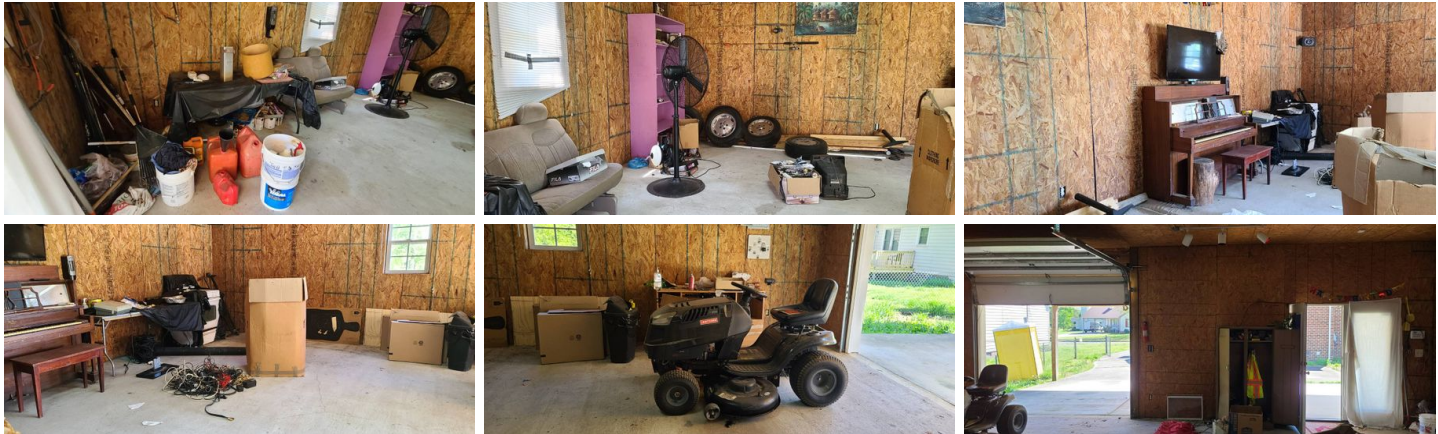
LIMITED VIEW OF GARAGE DUE TO STORED ITEMS

Noted limited view of the garage due to stored items.

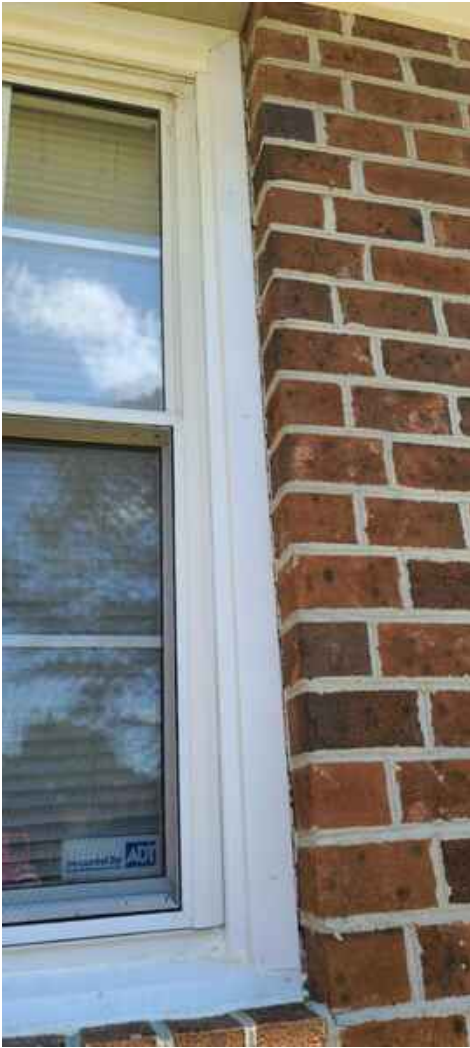
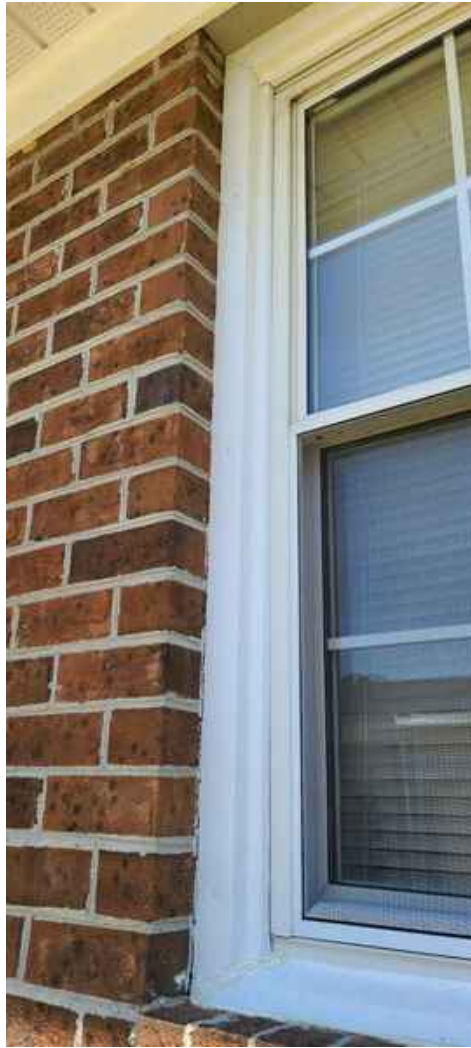
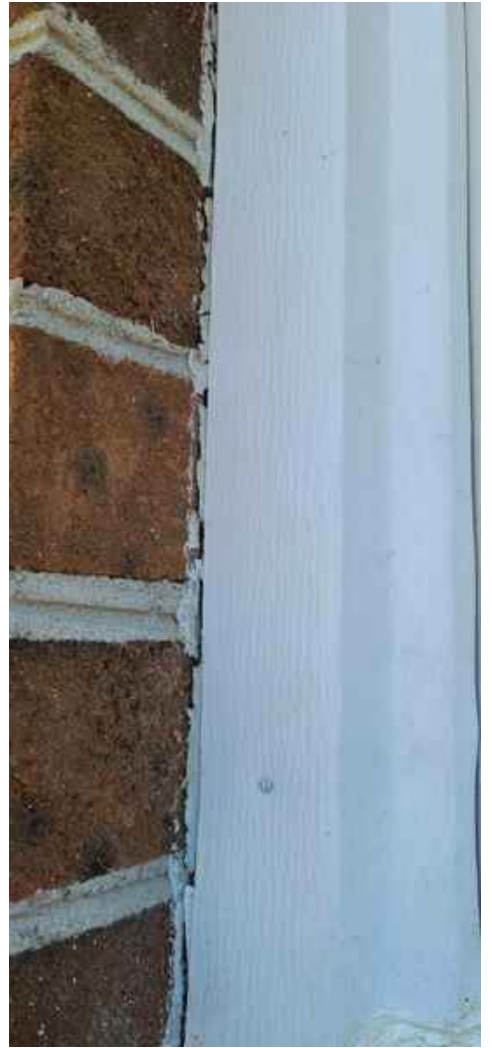
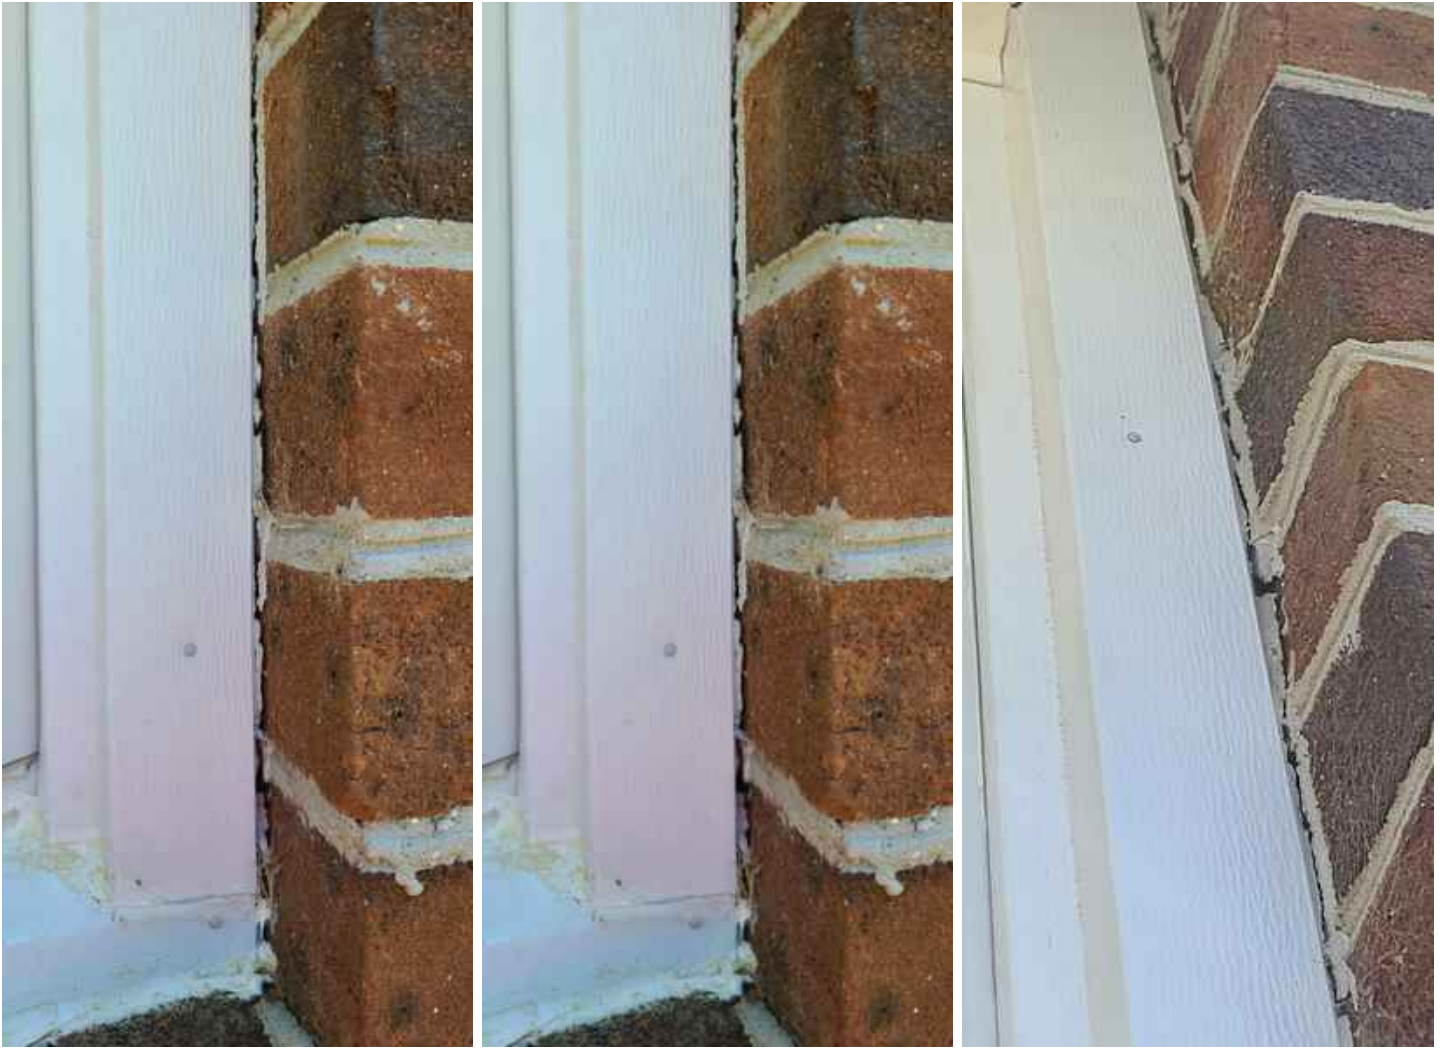
CRACKS/GAPS BETWEEN BRICK VENEER AND WINDOW TRIM

There were cracks/gaps between the brick veneer and the wood/trim on the exterior of the house. The cracks/gaps can allow water infiltration. The cracks/gaps need to be repaired by a qualified contractor.

Contact a qualified professional.

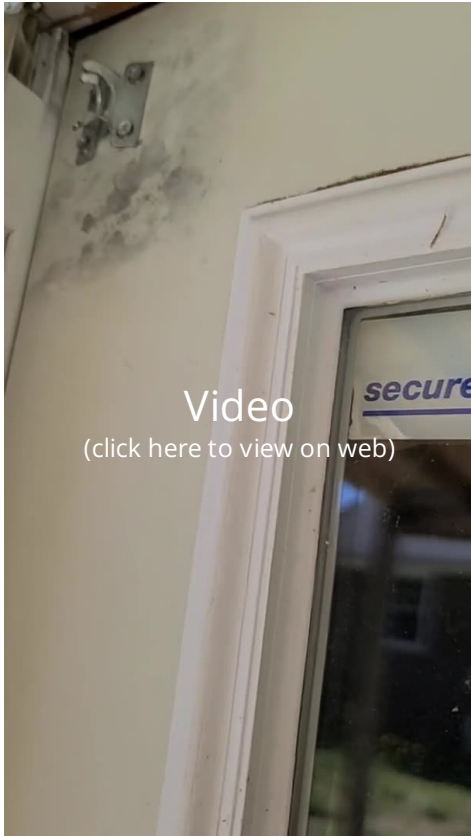
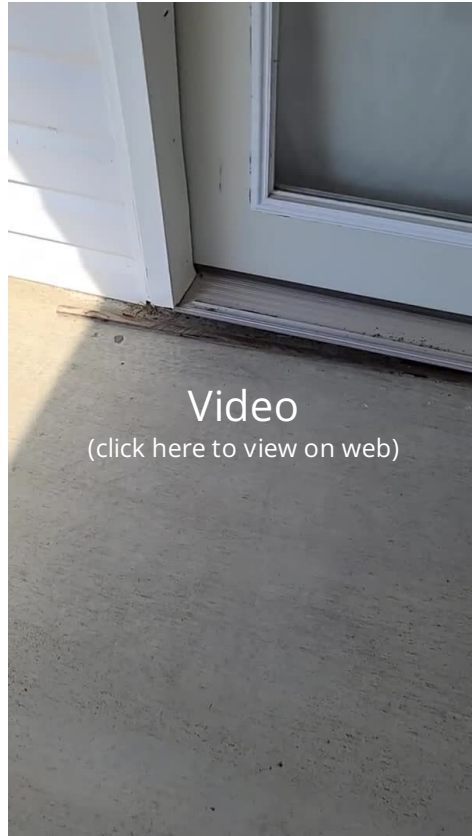
Minor Defect/Maintenance Item

There was no support under the outside edge of the threshold on the exterior door in the location(s) listed above. This can allow the threshold to move when it is stepped on. Movement in the threshold can allow it to be damaged. The door(s) need to be repaired by a qualified contractor.

Contact a qualified door repair/installation contractor.

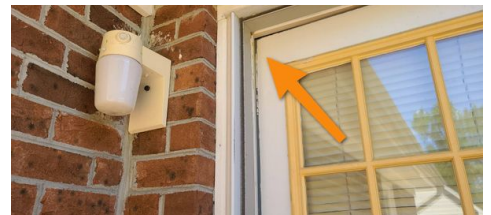
3.6.3 Entryway Doors

DOOR SCRUBBED

The exterior door in the location(s) listed above scrubbed the door jamb and/or threshold and was difficult to open/close. This can damage the door and also prevent it from closing/latching properly. The door(s) need to be repaired by a qualified contractor.

Contact a qualified door repair/installation contractor.

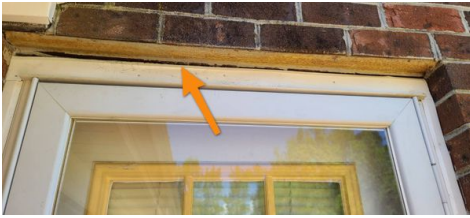
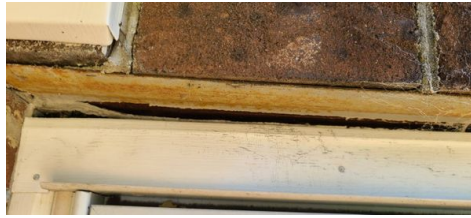
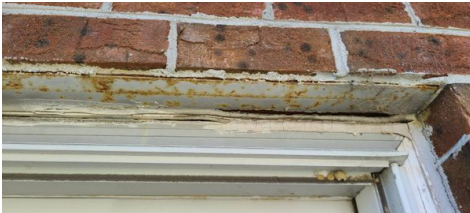
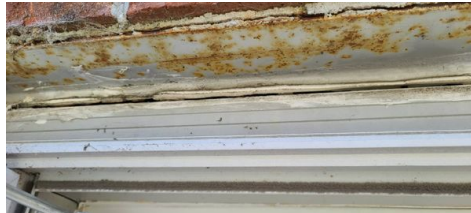
3.6.4 Entryway Doors

DAMAGED/ MISSING SEALANT

The exterior doors in the location(s) listed above had damaged/ missing sealant on the door's exterior. This could allow the door to absorb water, which could cause decay/deterioration of the door. There was no visible damage to the door during the inspection. The door(s) need to be repaired by a qualified contractor.

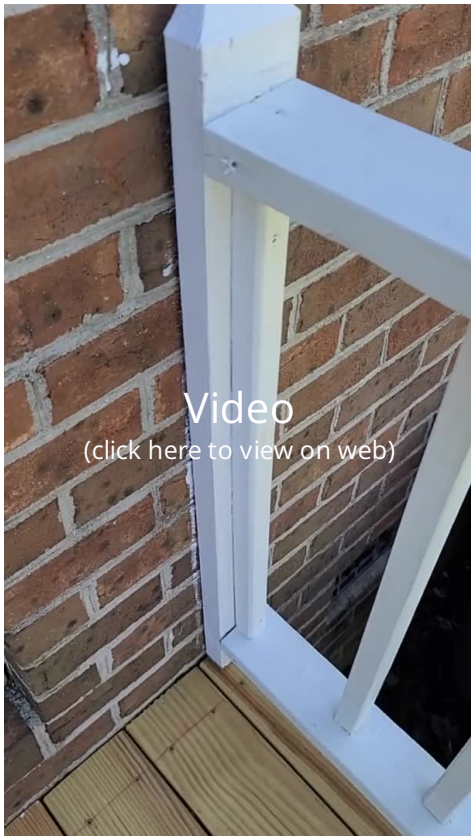
3.8.1 Porch/Stoop

LOOSE RAILS - LOCATION

The rails on the location listed above porch were loose (directions for rails are relative to facing the porch). Loose rails could allow a person to fall and be injured. The rails need to be repaired by a qualified contractor.

Contact a qualified deck contractor.

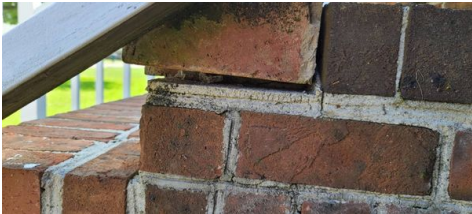
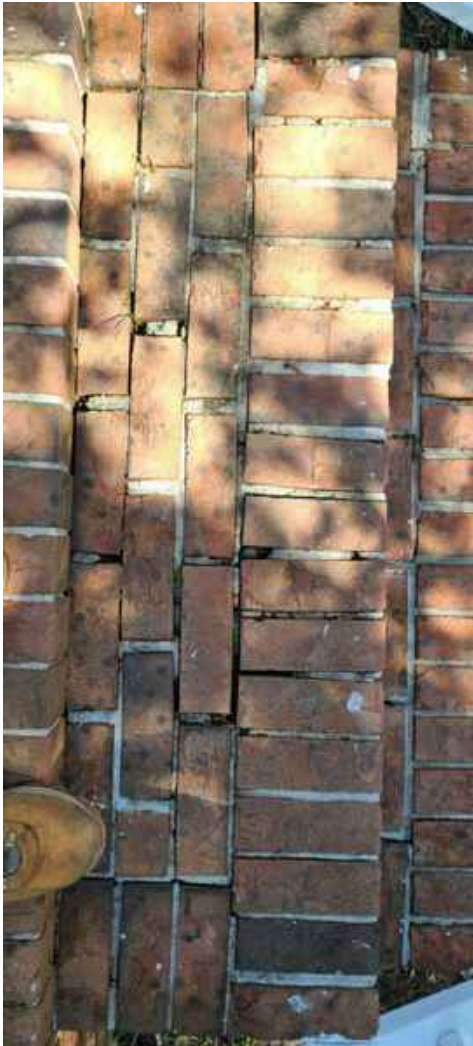
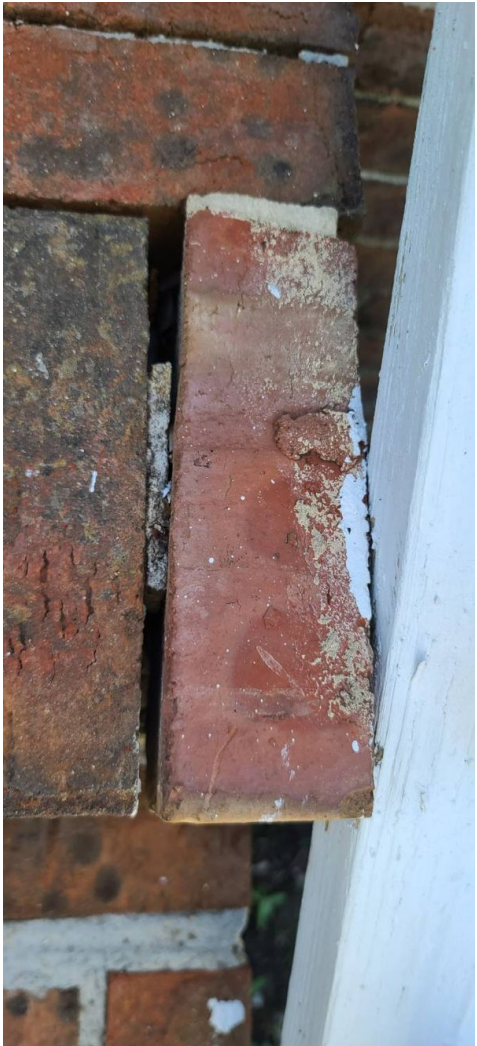
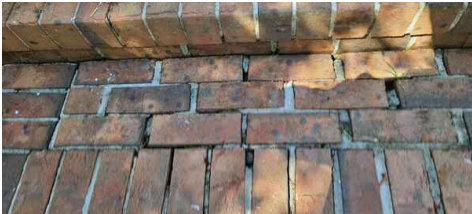
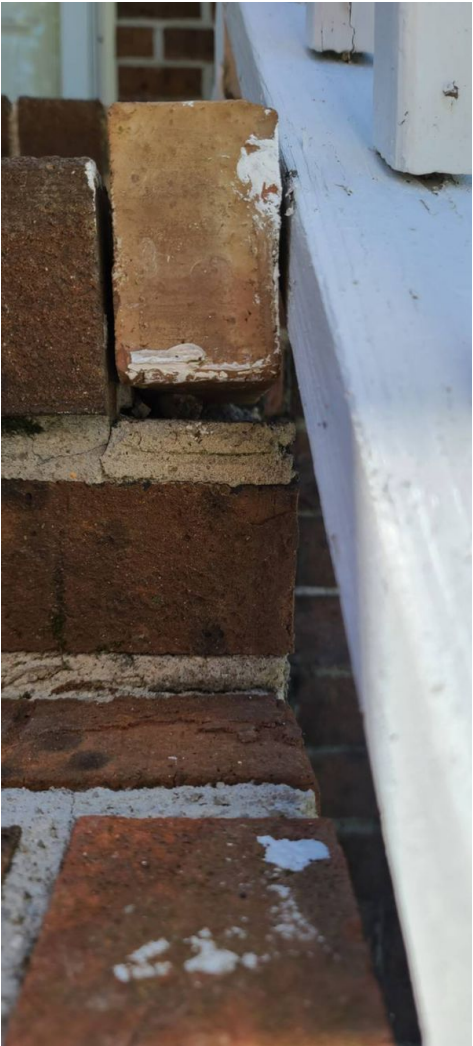
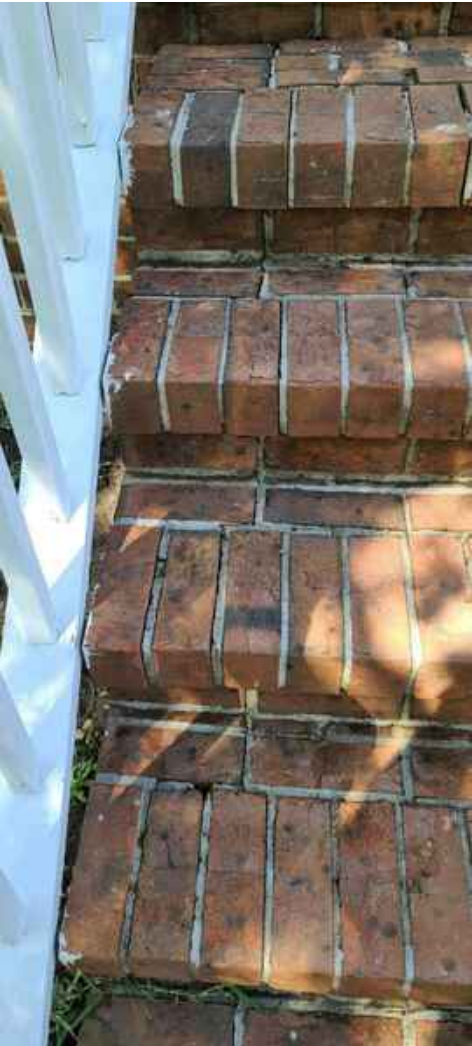
CRACKS IN MORTAR ON STEPS

There were cracks in the mortar in the masonry porch steps in the location listed above. The cracks can allow water infiltration, which could cause problems over the years. This area in the crawl space is very wet. The cracks need to be repaired by a qualified contractor.

Contact a qualified masonry professional.

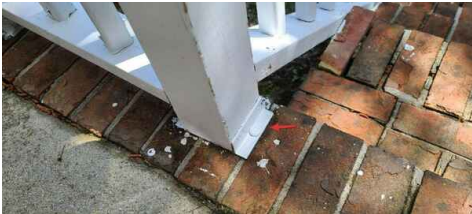
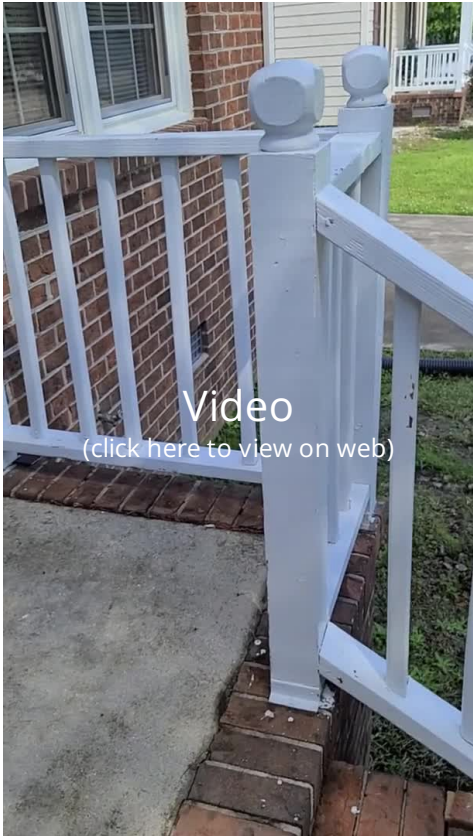
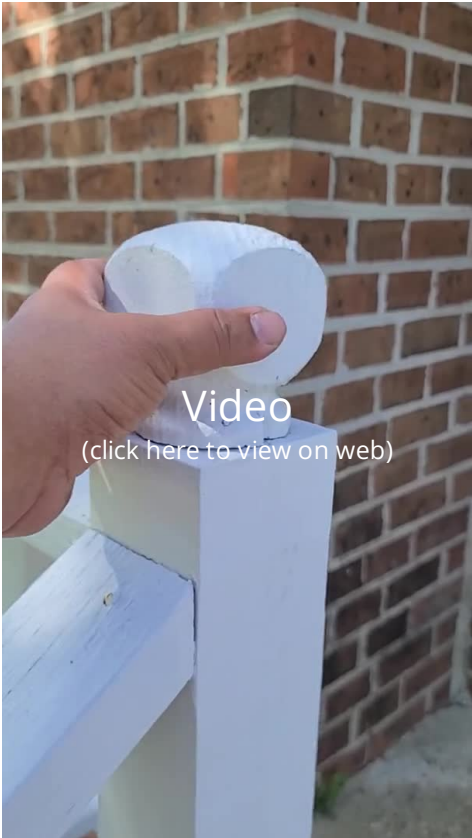
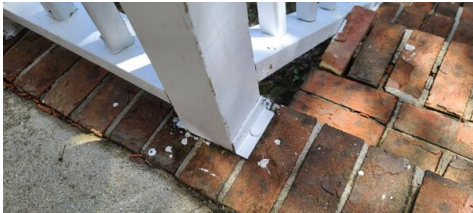
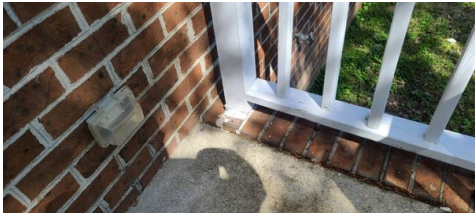
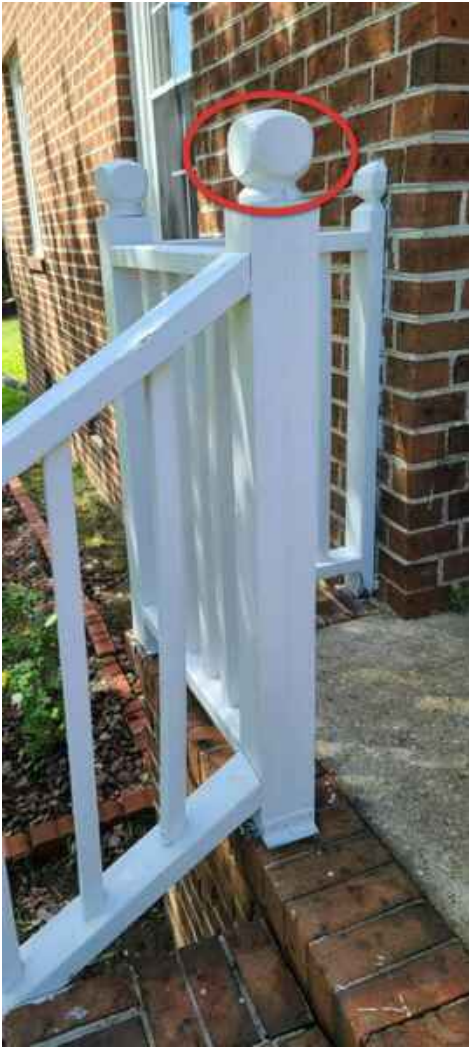
3.9.1 Steps/Rails

LOOSE RAIL ON STEPS

The rail on the location(s) listed above of the location(s) listed above steps was loose, which creates a falling hazard. The rail needs to be repaired by a qualified contractor.

Contact a qualified deck contractor.

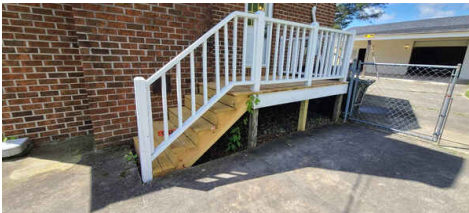
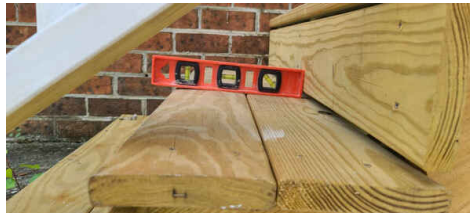
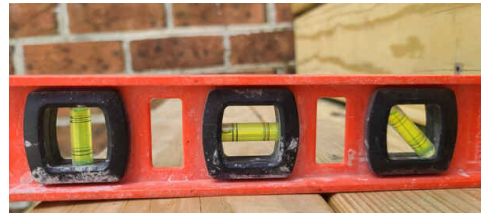
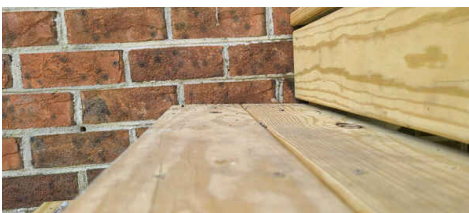
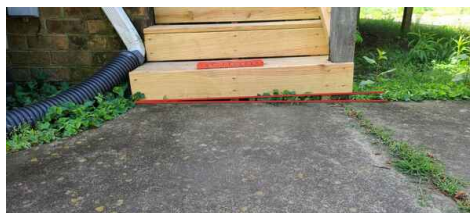
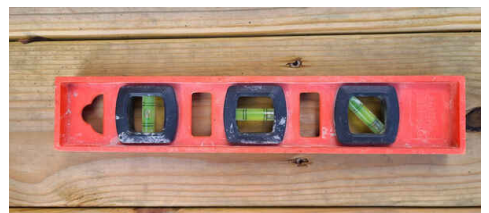
3.9.2 Steps/Rails

LOCATION STEPS NOT LEVEL

The steps on the location(s) listed above of the house were not level. The treads on the steps sloped down, which creates a tripping/falling hazard. The steps need to be repaired/replaced by a qualified contractor.

Contact a qualified deck contractor.

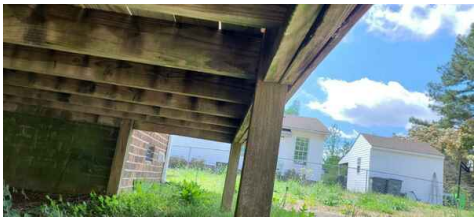
3.10.1 Deck

EXPOSED NAILS

There were exposed nail tip(s) on the location(s) listed above on the deck. The exposed nail tips could injure a person. The exposed nail(s) need to be repaired by a qualified contractor.

Recommendation
Contact a qualified professional.

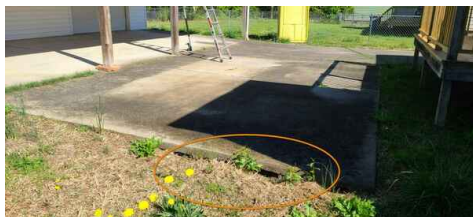
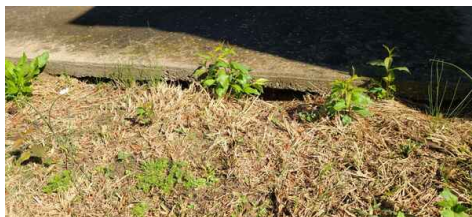
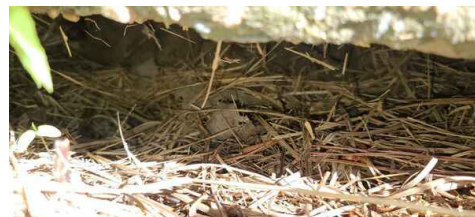
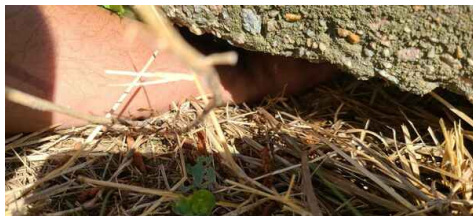
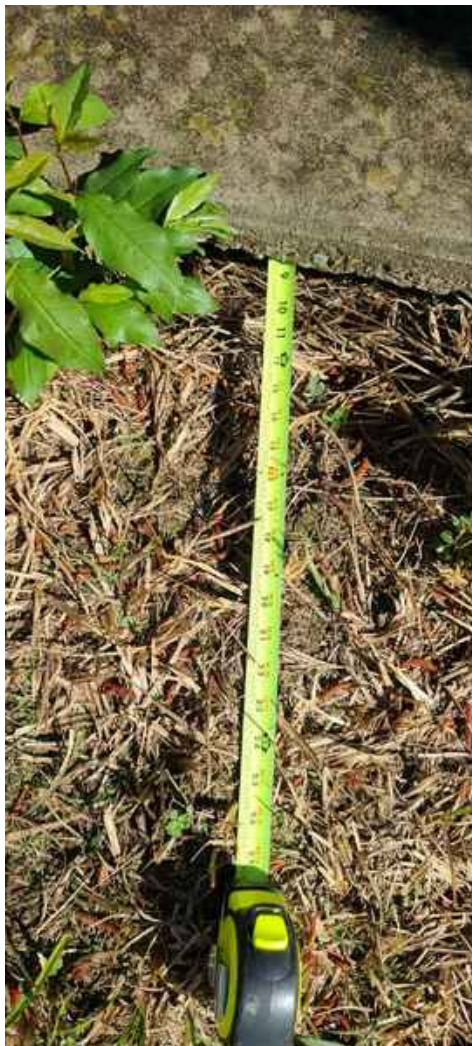
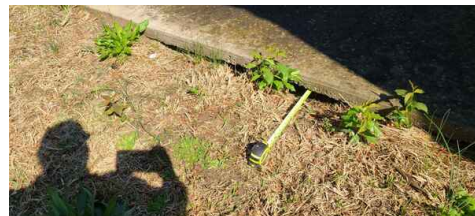
3.11.1 Patio

VOIDS UNDER CONCRETE SLAB

There was no backfill under the front left corner of the concrete slab. The edge of the slab has no direct earth support and may break under the weight of a motor vehicle. This needs to be evaluated and repaired by a qualified professional.

Contact a qualified concrete contractor.

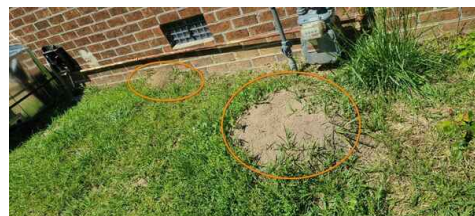
3.11.2 Patio

I noticed a large colony of fire ants on the house's left side by the gas meter and HVAC unit. Fire ants can deliver very painful bites and stings when they're agitated. Left untreated, this can become hazardous to children or someone walking barefoot. The seller should consult with a pest control specialist to prevent migration into the house and to determine the best course of correction.

Contact a qualified professional.

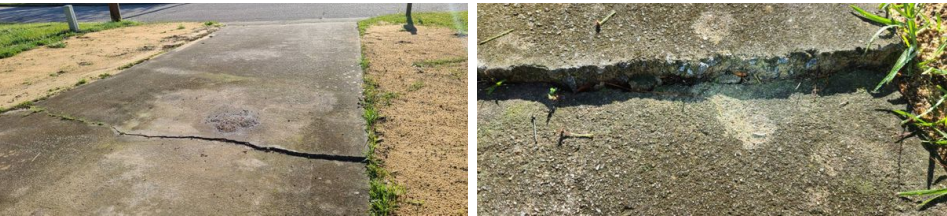
3.12.1 Driveway

CRACKS WITH HEIGHT CHANGE

There were cracks in the driveway that had height changes, which can indicate movement occurring in/under the driveway and creates tripping hazards. The driveway needs to be repaired/replaced by a qualified contractor.

Contact a qualified concrete contractor.

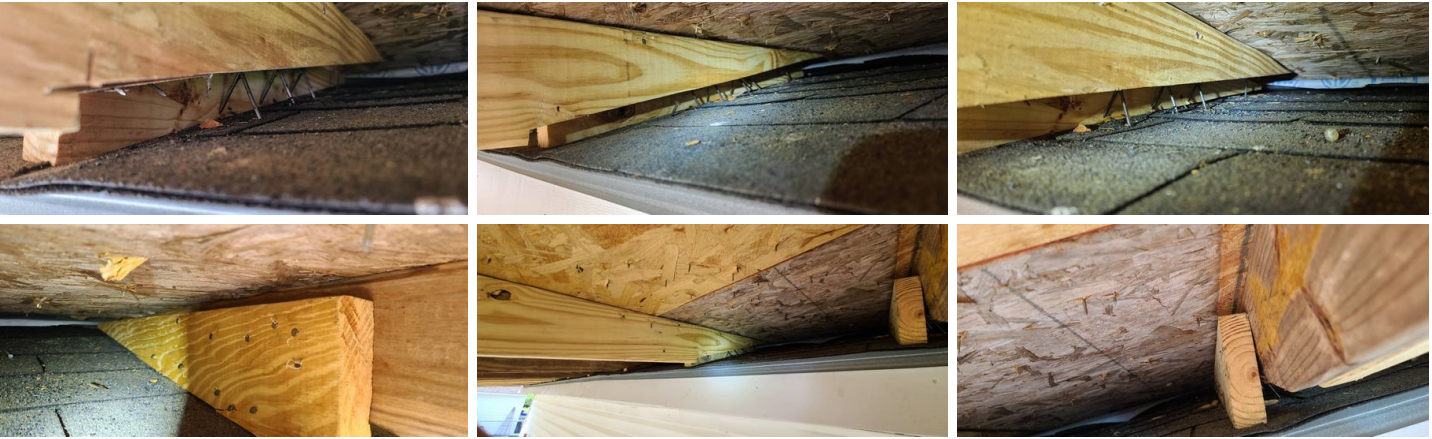
3.14.1 Garage/Carport

Many rafters in the carport shed roof framing system are not correctly fastened. The joists do not transfer the roof load directly onto the garage roof structure it is supposed to be anchored to. A small wooden wedge suspends the shed roof joists. This construction method does not comport with current best practices and industry standards. The roof may not be able to perform as intended and should be evaluated and repaired by a licensed general contractor.

Rafter is not doubled—missing rafter.

Contact a qualified general contractor.

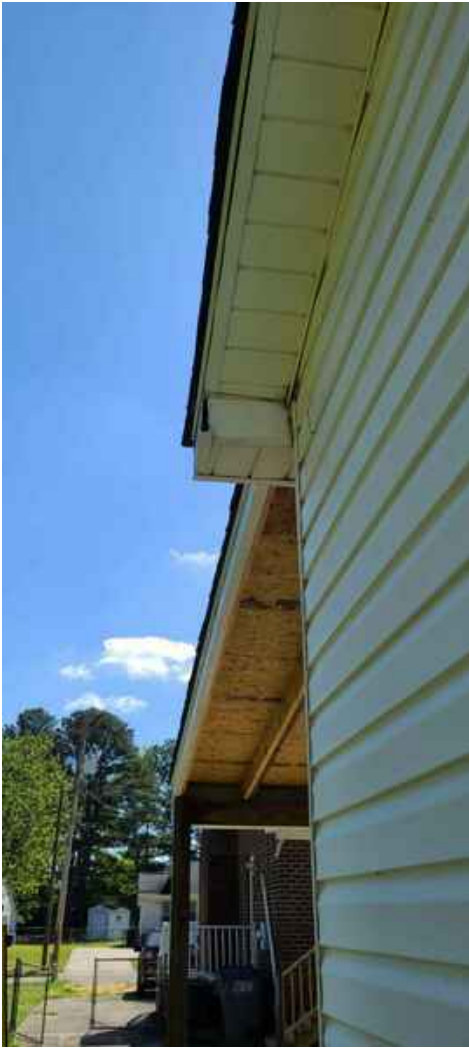
CRACKS/GAPS IN ALUMINUM OVER TRIM

There were cracks in the junctions of the aluminum cladding over the trim in the location(s) listed above on the exterior of the house. The cracks can allow water infiltration. There could be hidden damage in these area(s). The area(s) need to be repaired by a qualified contractor.

Contact a qualified siding specialist.

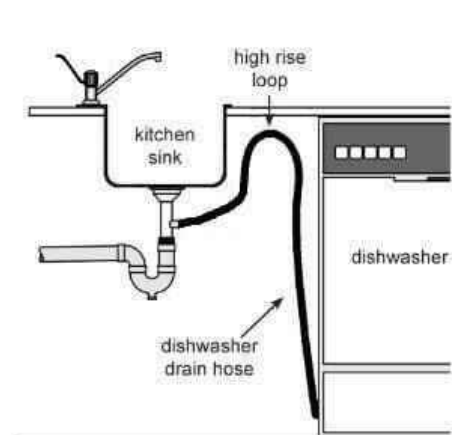
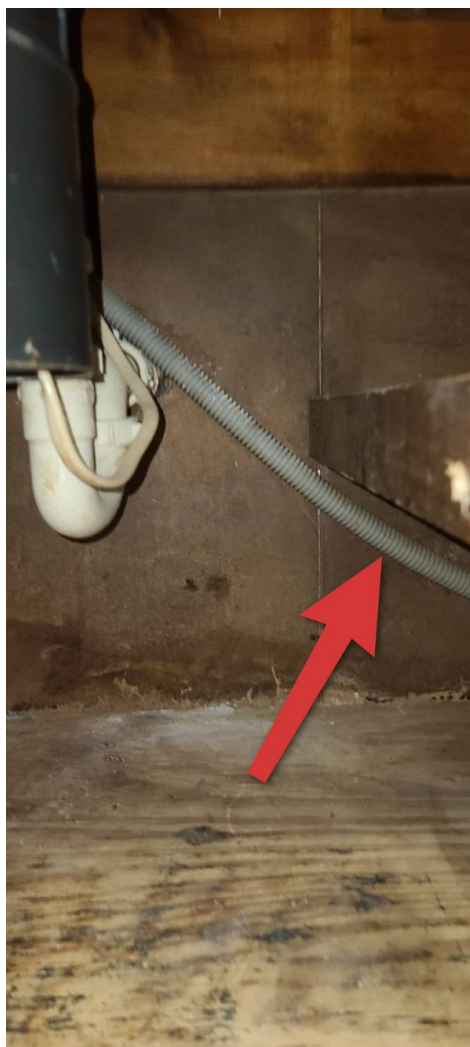
The dishwasher drain pipe in the cabinet under the kitchen sink did not loop up to the top of the cabinet. The current installation can allow dirty water from the sink to drain into the clean environment of the dishwasher. The dishwasher drain needs to be repaired by a qualified contractor.

Contact a qualified plumbing contractor.

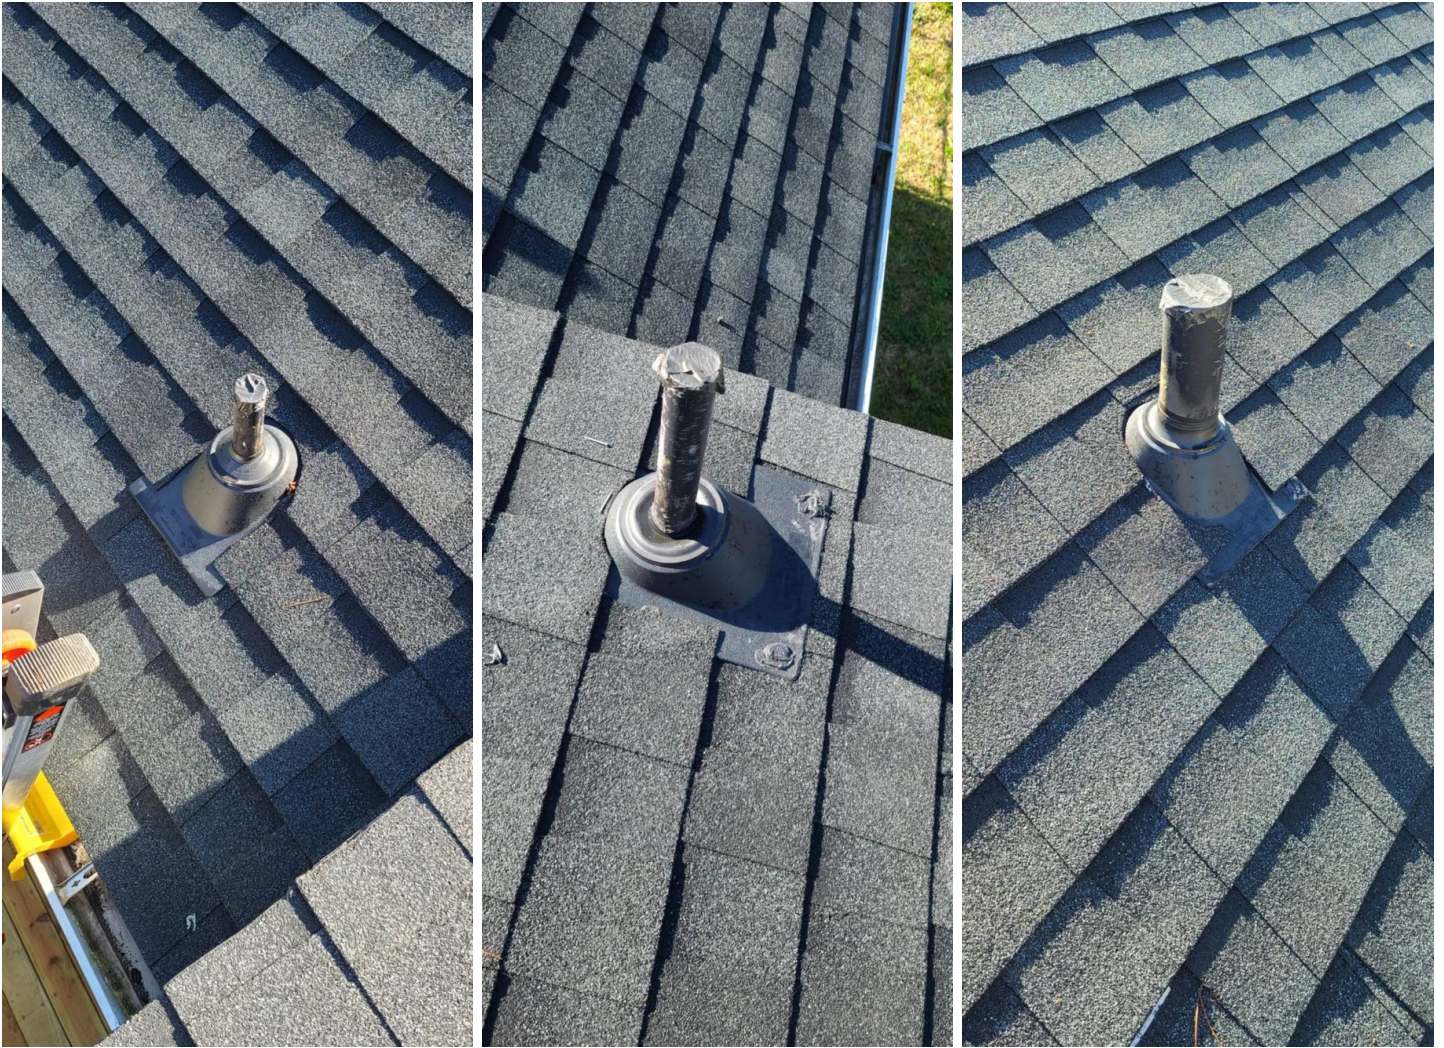
4.3.2 Drain/Waste/Vent System

PLUMBING VENT PIPES SEALED SHUT

Every vent pipe had adhesive tape sealing the ventilation shut. It appears the tape was placed there so that the pipes can be spray-painted black. These seals could prevent airflow into the pipes, restricting drainage performance throughout the entire plumbing system. The vent pipe needs to be evaluated by a licensed plumbing contractor and repaired as necessary.

Contact a qualified professional.

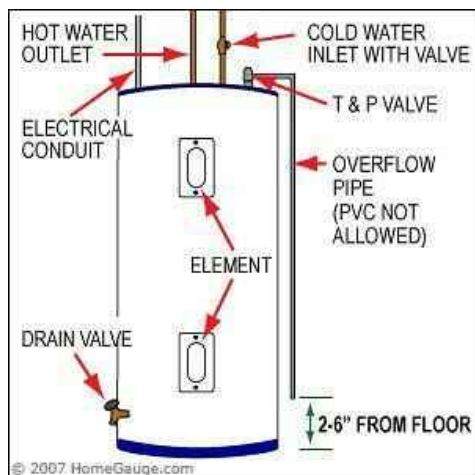
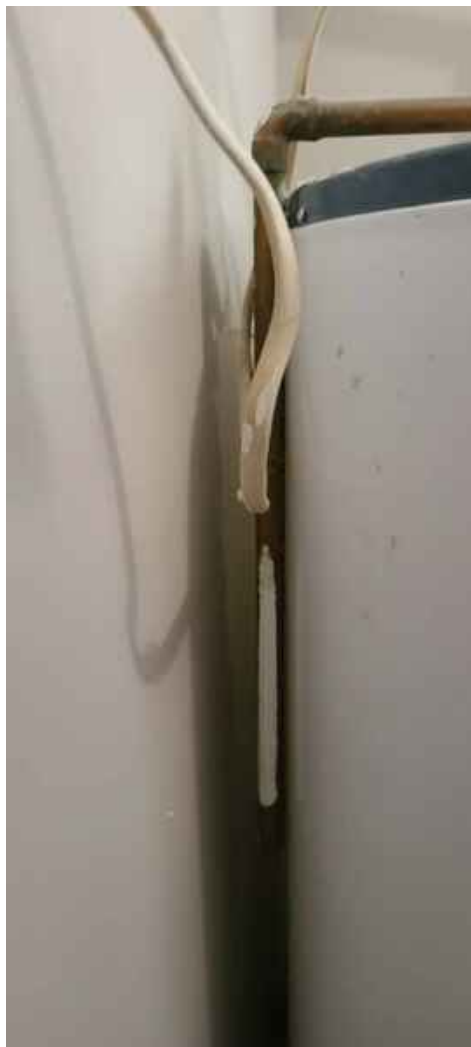
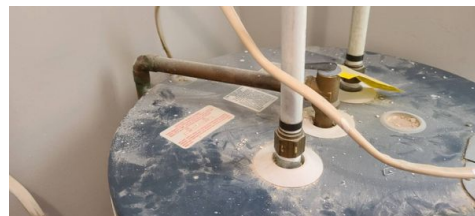
4.4.1 Water Heater

TPR NOT TO FLOOR

The water heater did not have its temperature/pressure relief (TPR) valve piped to the floor/ground, which creates a scalding hazard. The TPR valve needs to be repaired by a licensed plumbing contractor.

Contact a qualified plumbing contractor.

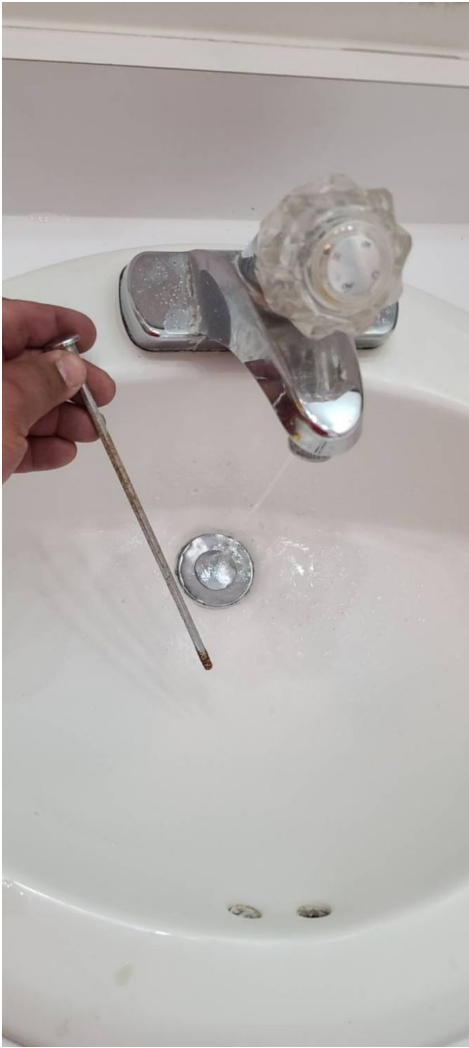
4.10.2 Bathroom Sinks

LEAKING FAUCET

There was very no hot water service at the faucet. Inspector checked the hot water service valve and noticed that it was turned off. Inspector turned on the hot water service valve, and the tap produced hot water. However, the faucet would not stop running the hot water when the faucet was turned off. The inspector shut the hot water service valve to prevent any flooding. This needs to be evaluated and repaired by a qualified plumber.

Contact a qualified plumbing contractor.
