DUE DILIGENCE PROPERTY INSPECTIONS

OFFICIAL PROPERTY INSPECTION REPORT(*)

1234 Main Street
Rocky Mount, NC 27803

Buyer Name
05/08/2023 9:00AM

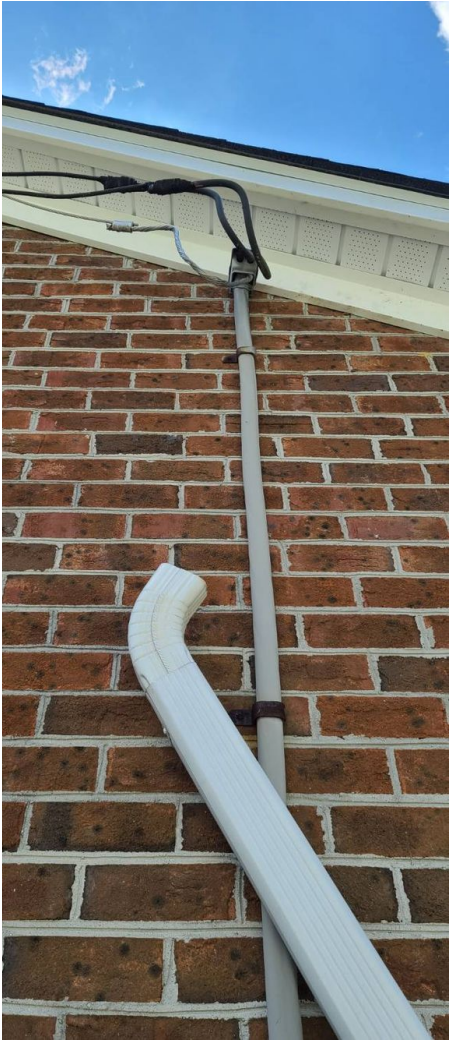
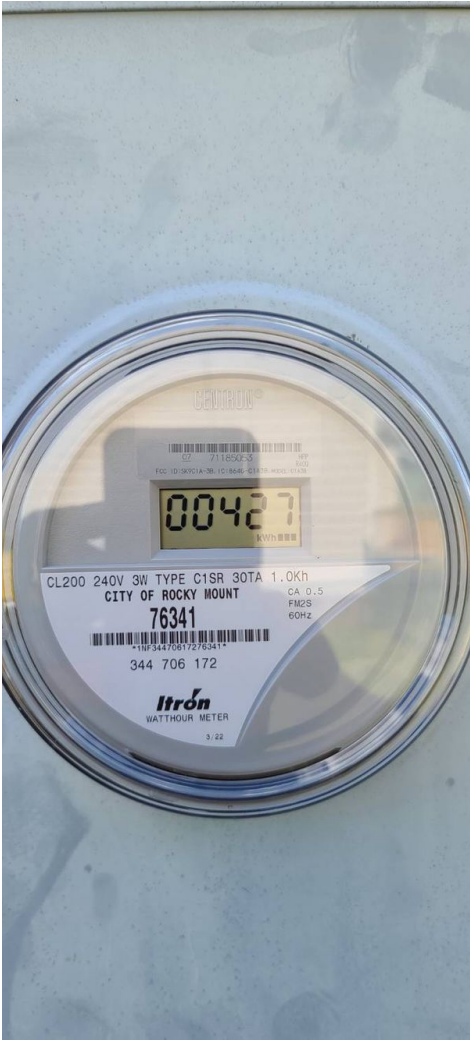
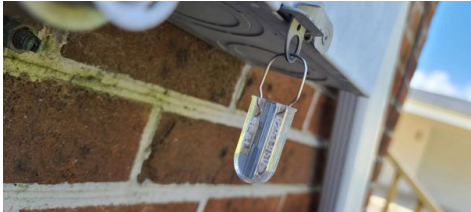
Service Entrance: Service Entrance Amps/Volts
200 amps

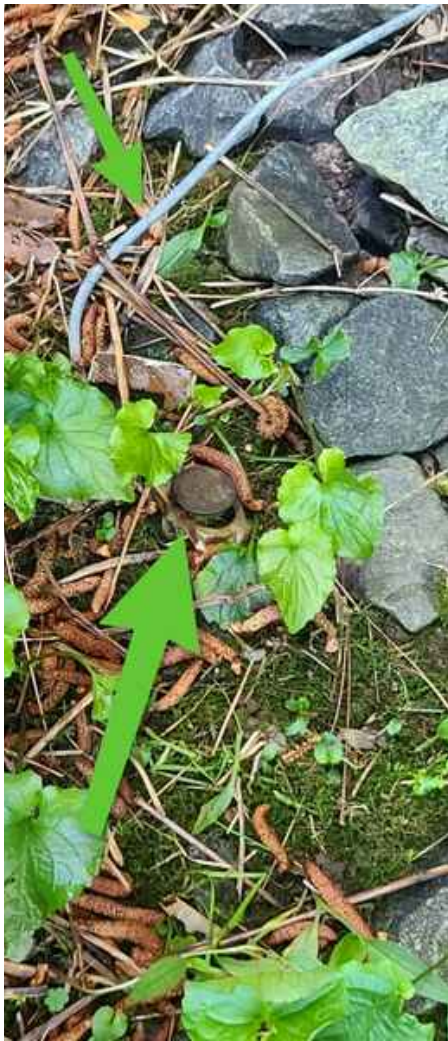
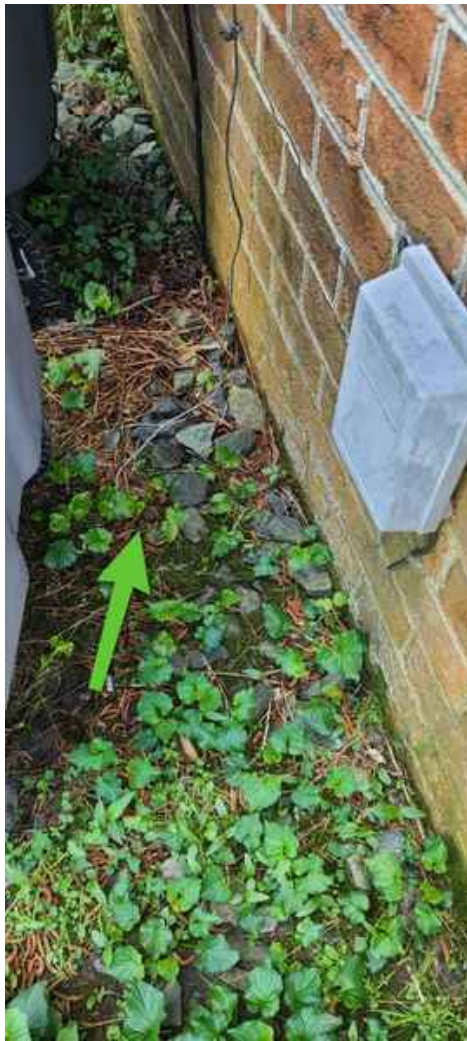
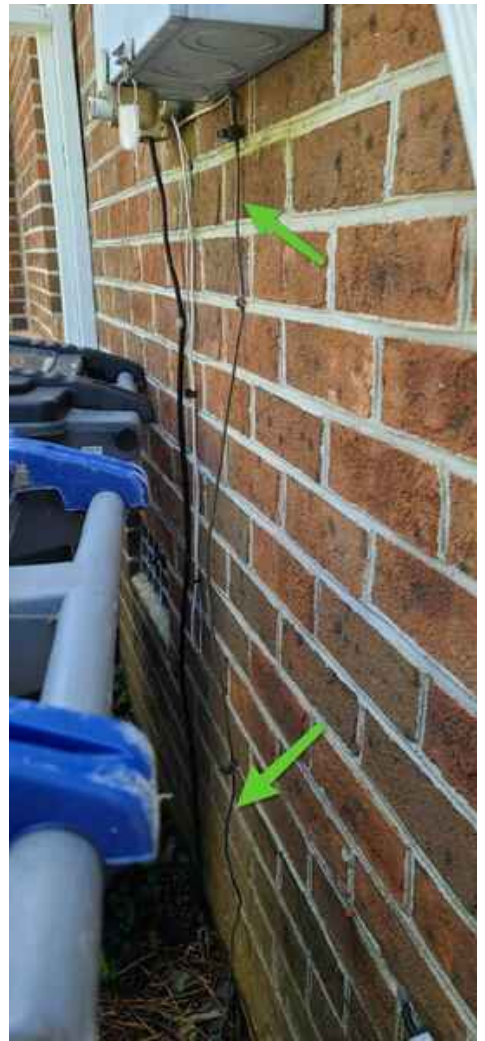
Service Ground: Slightly exposed above ground

Noted the ground stake was slightly exposed above the ground. Care needs to be taken around that wire/stake so they are not damaged by lawn equipment.

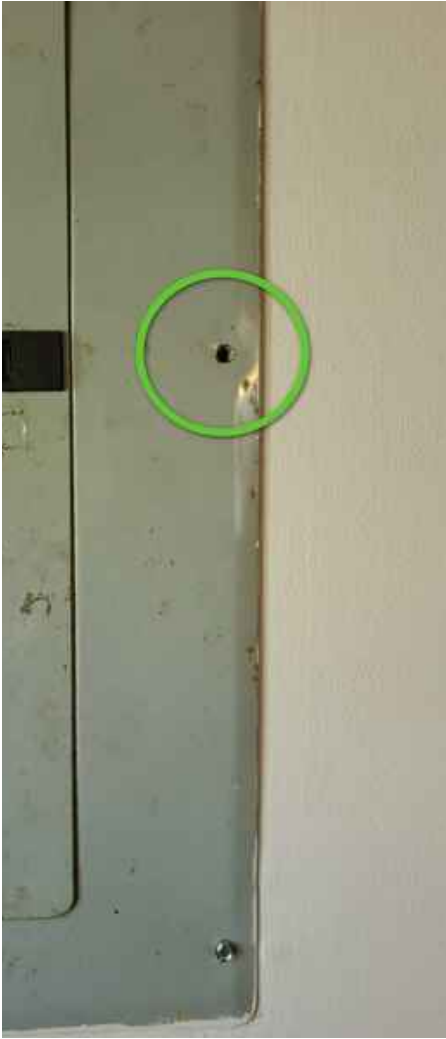
Main Panel: Missing screws main electrical panel cover but cover securely held

Noted missing screw(s) in the main electrical panel cover but the cover was securely held in place.

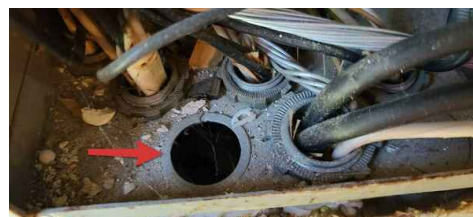
There were hole(s) in the main electrical panel. The hole(s) can allow animals to enter the panel, which could damage the electrical components in the panel. The hole(s) can allow oxygen to enter the panel, which could feed a fire inside the panel. The panel needs to be repaired by a licensed electrical contractor.

Contact a qualified electrical contractor.

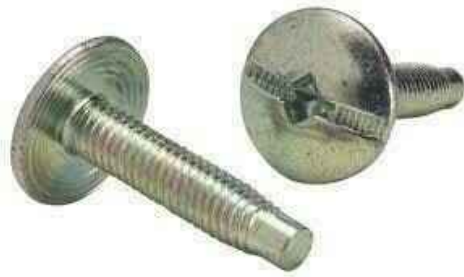
**5.3.2 Main Panel****SHARP SCREWS**

There were screw(s) in the main electrical panel cover with sharp point(s) and sharp threads, which could damage an electrical wire while inserting or removing the screws. This creates a shocking hazard. The approved panel cover screws need to be replaced by a licensed electrical contractor.

Contact a qualified electrical contractor.

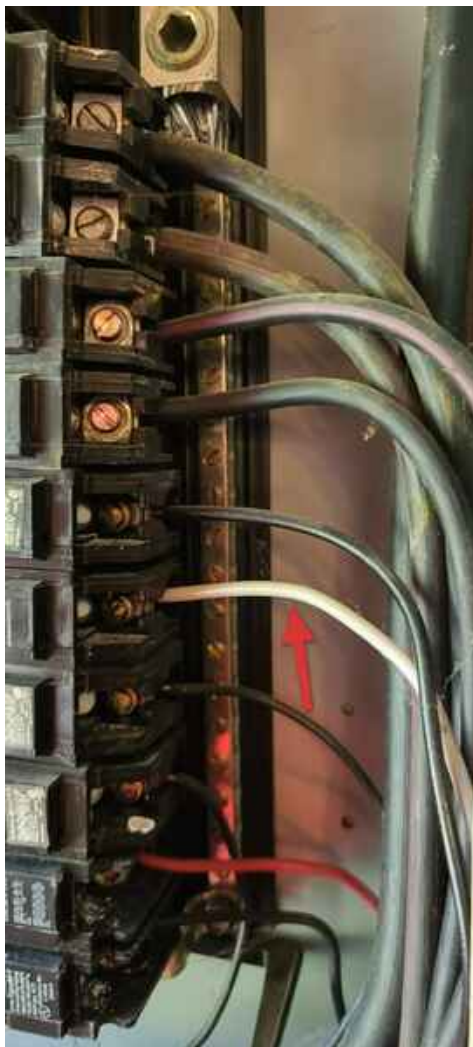
5.6.1 Circuit Conductors

There were white wire(s) connected to breaker(s) in the electrical panel in the location(s) listed above. When white wires are connected to a breaker, the wire has to be marked/taped/colored black to indicate that it is a hot wire. White wires connected to a breaker that are not labeled could confuse a person working in the electrical panel. The white wires were not properly labeled as black to indicate that they were hot wires. This creates shocking hazards. The wire(s) need to be repaired/replaced by a licensed electrical contractor.

Contact a qualified electrical contractor.

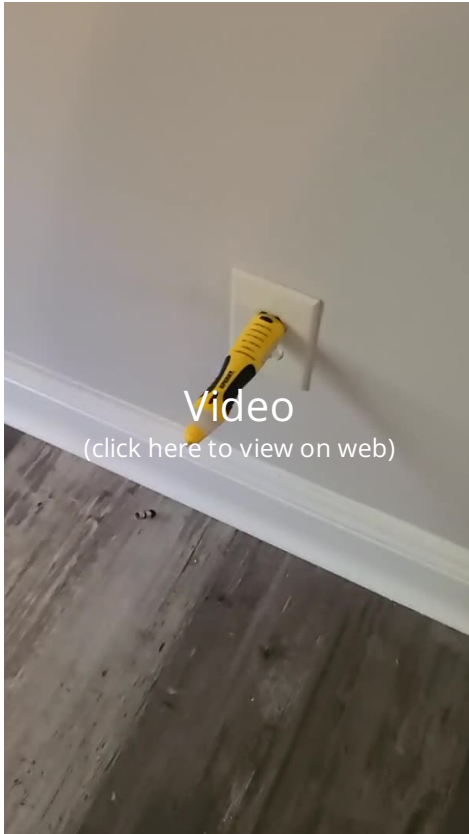
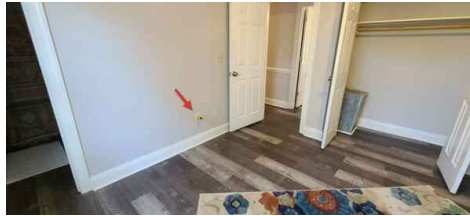
5.10.1 Interior Receptacles

DAMAGED RECEPTACLE

There were damaged receptacle(s) in the location(s) listed above. This creates shocking hazards. The receptacle(s) need to be repaired/replaced by a licensed electrical contractor.

Contact a qualified electrical contractor.

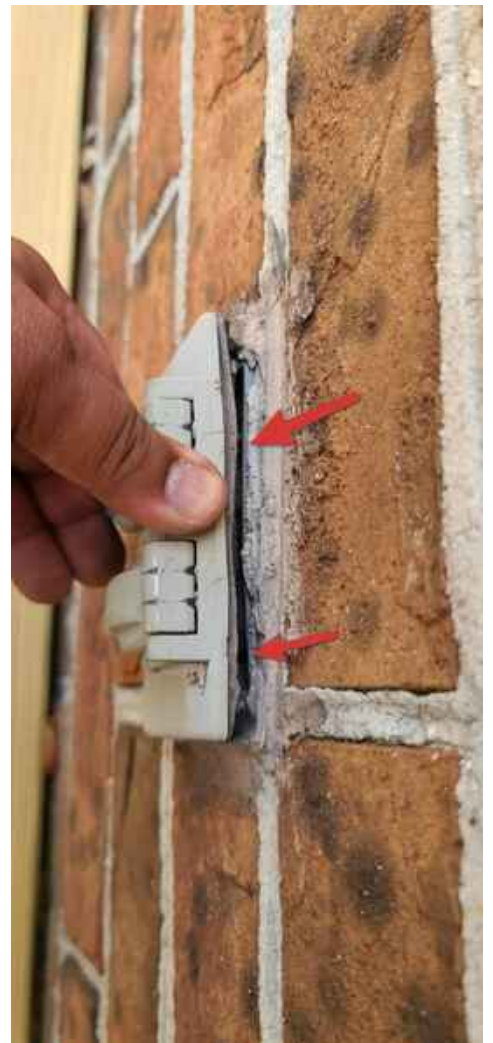
5.11.1 Exterior Receptacles

DAMAGED WEATHER COVER

The receptacle in the location listed above on the exterior of the house was loose and had deteriorated weather cover seal. This can allow dirt/debris/moisture into the receptacle. The receptacle(s) need to be repaired by a licensed electrical contractor.

Contact a qualified electrical contractor.

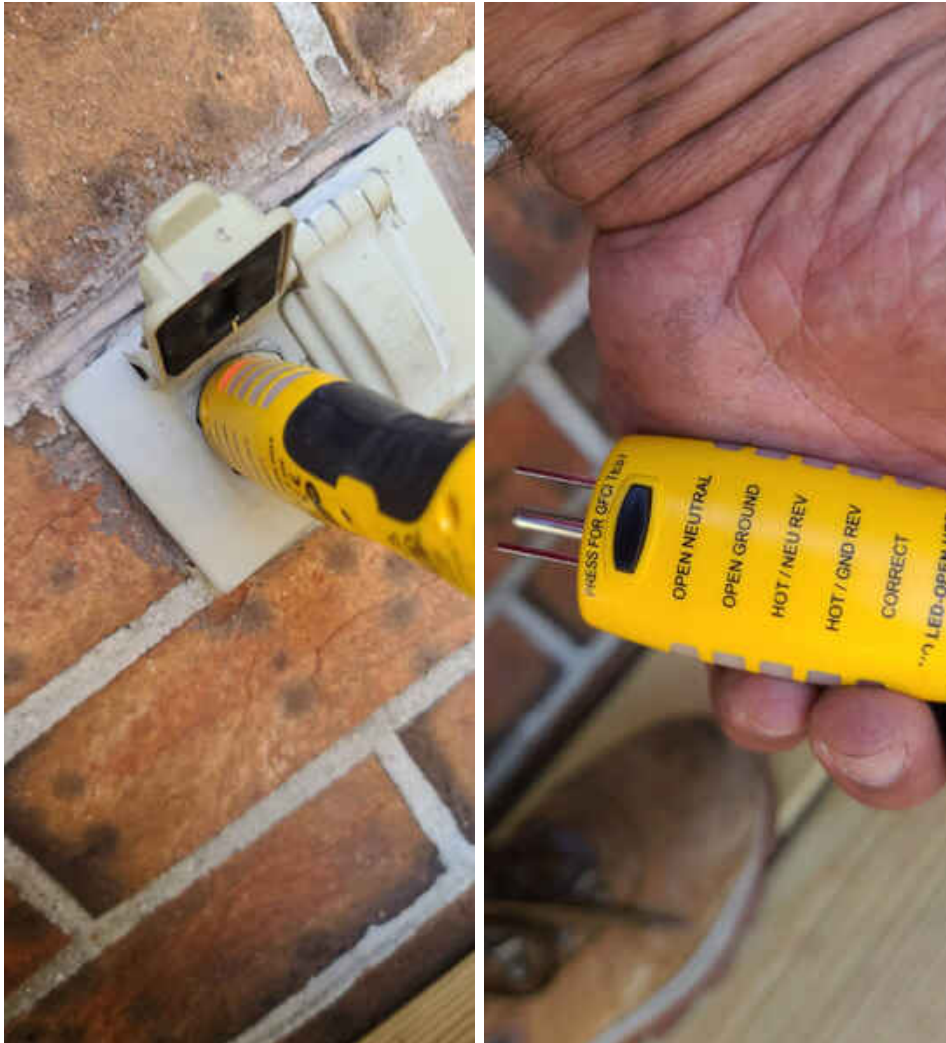
5.11.2 Exterior Receptacles

NO NEUTRAL

The receptacle(s) on the location(s) listed above on the exterior of the house had no neutral. This creates a shocking hazard and could prevent equipment from working correctly in the receptacle. The receptacle(s) need to be repaired/replaced by a licensed electrical contractor.

Contact a qualified electrical contractor.

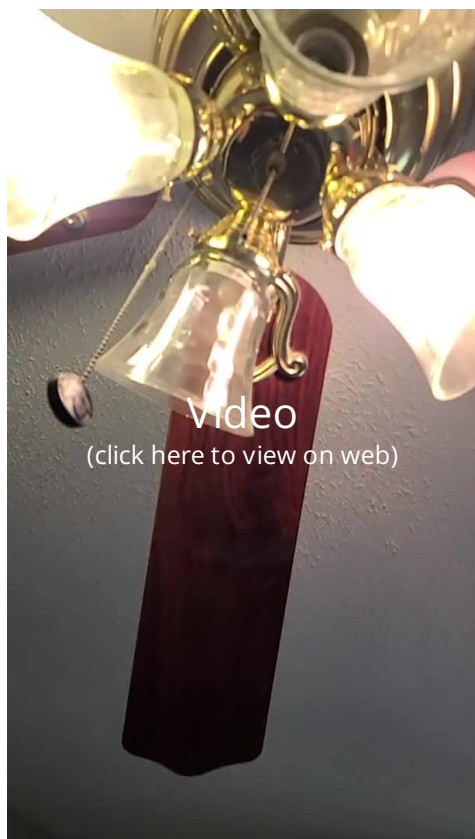
5.15.1 Ceiling Fans

DID NOT WORK

The ceiling fan(s) in the location(s) listed above did not work and could not be used/tested. The ceiling fan(s) need to be repaired/replaced by a licensed electrical contractor.

Contact a qualified electrical contractor.

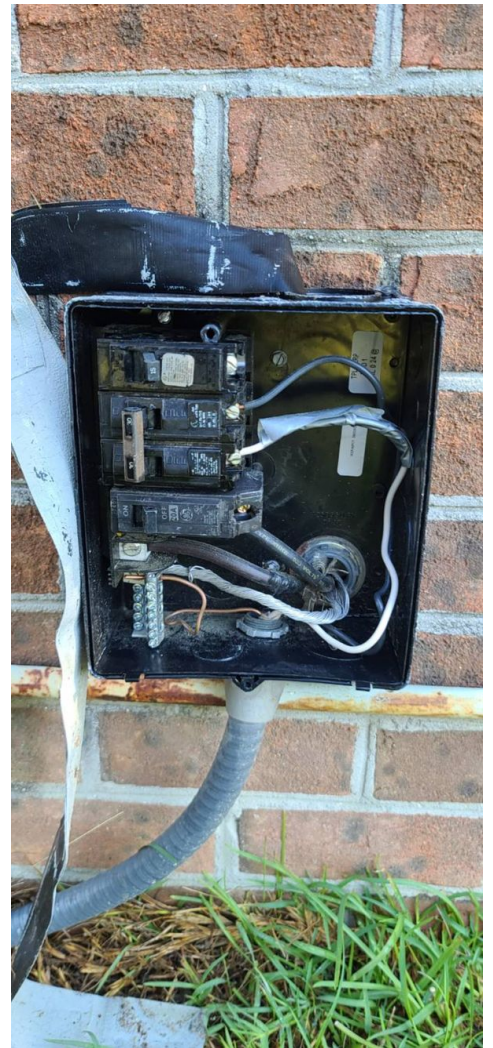
**MISSING SERVICE
DISCONNECT COVER**

The service disconnect cover was missing. The exposed conductors pose a shock hazard and needs to be repaired by a qualified electrician.

Contact a qualified electrical contractor.

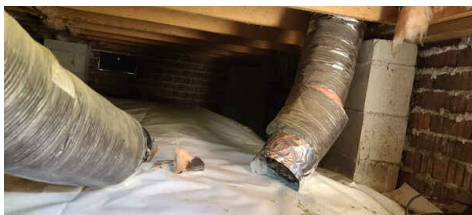
**AIR DUCTS WITH LOOSE CONNECTIONS OR WERE
DAMAGED**

There were air duct(s) in the locations listed above that had loose connection(s) and/or were damaged. This will allow conditioned air to flow into an unconditioned area, which is wasteful and can prevent the HVAC system from properly heating/cooling the house. The air duct(s) need to be repaired by a licensed mechanical contractor.

This to the right of the access door opening

Contact a qualified insulation contractor.

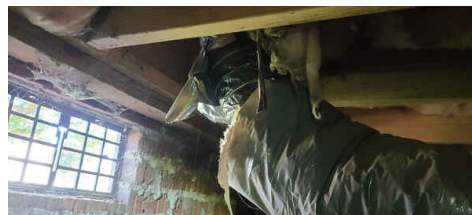
This duct is toward the front of the house.

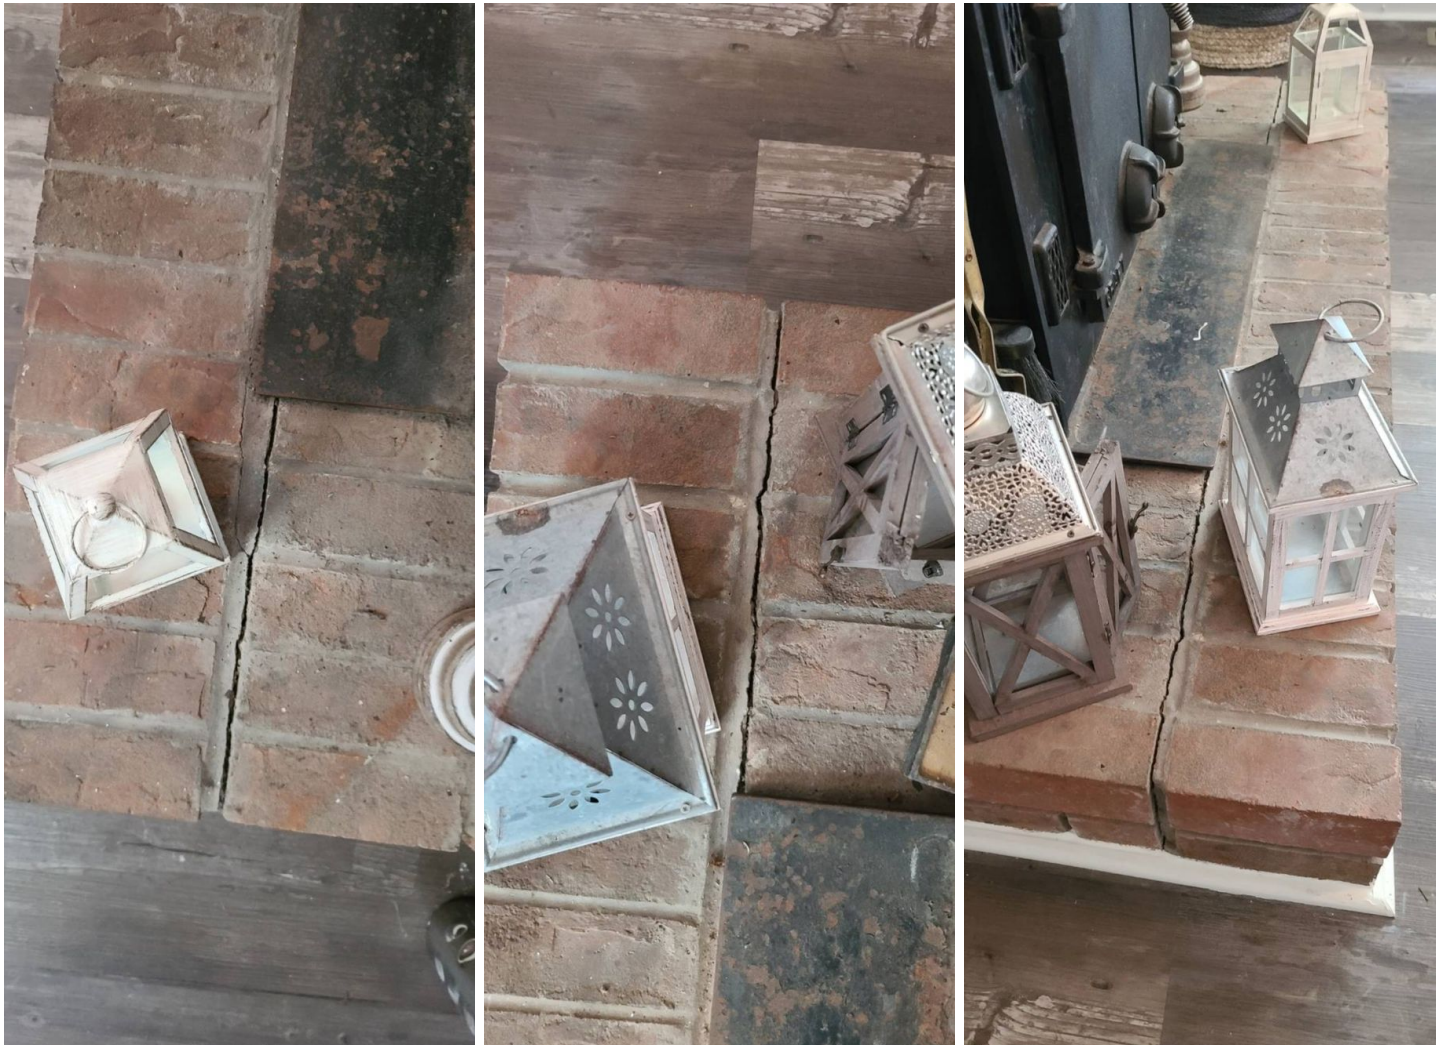
MORTAR CRACK/ SEPARATION

The hearth had a separation in the mortar that extended the entire width of the hearth. This presents a fire hazard should embers fall into the crack. The hearth must be evaluated to determine the cause of the crack and repaired by a qualified chimney repair contractor before it is used.

Contact a qualified chimney contractor.

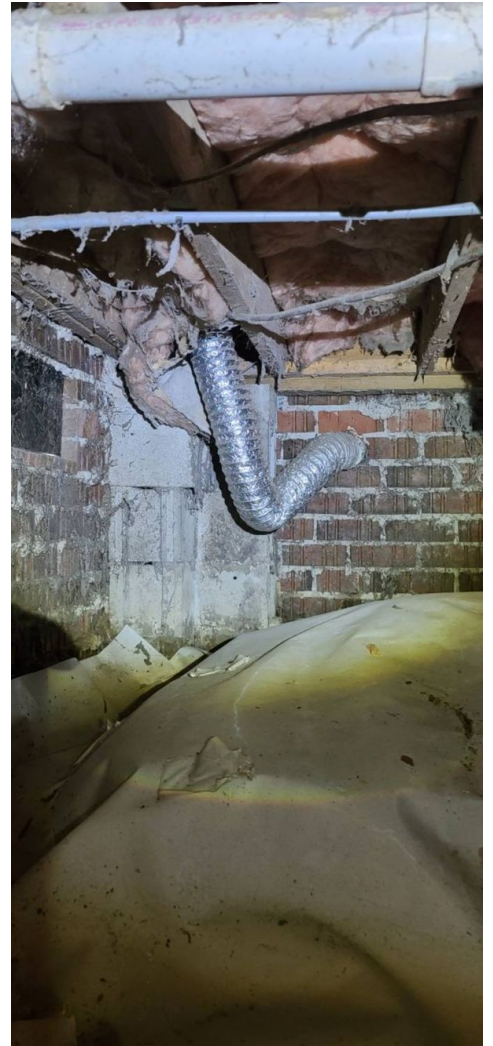
The laundry vent pipe in the crawl space was a flexible pipe with dips/valleys. The flexible pipe can retain debris/lint, which creates a fire hazard. The laundry vent pipe needs to be replaced by a qualified contractor.

Contact a qualified professional.

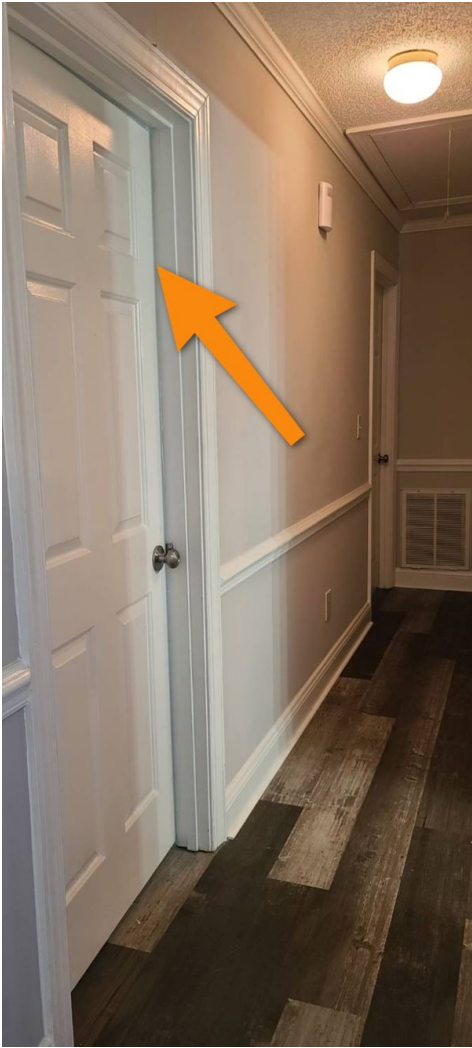
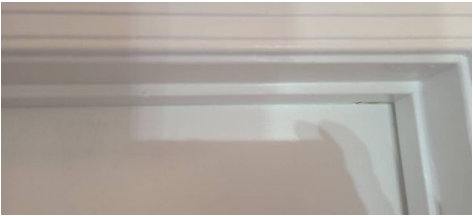
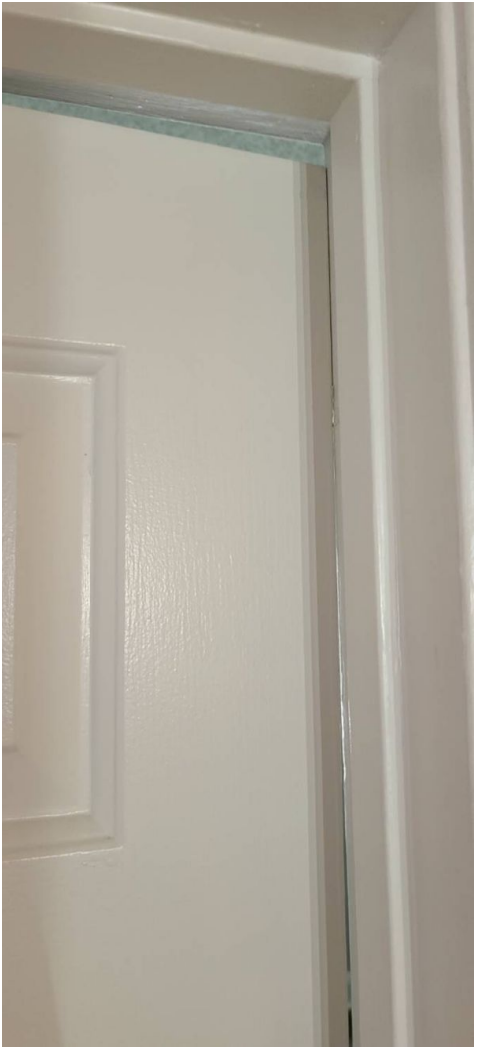
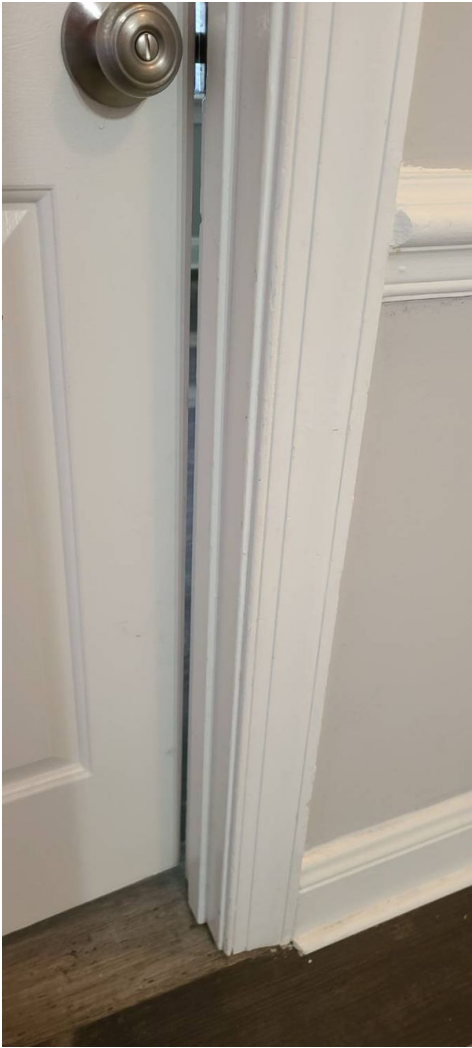
The door(s) listed above scrubbed. Thus, the door(s) would not close or were difficult to open/close. The door(s) need to be repaired by a qualified contractor.

Contact a qualified door repair/installation contractor.

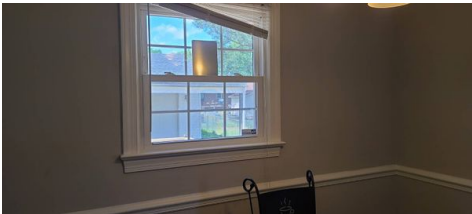
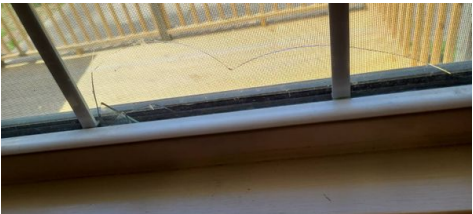
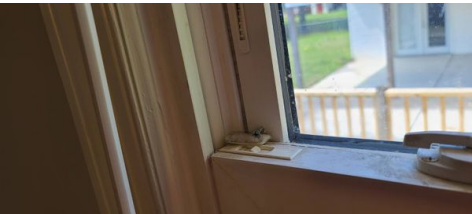
BROKEN GLASS

Window(s) in the location(s) listed above had broken glass. The broken glass could injure a person. The damaged window(s) need to be repaired/replaced by a qualified contractor.

Contact a qualified window repair/installation contractor.

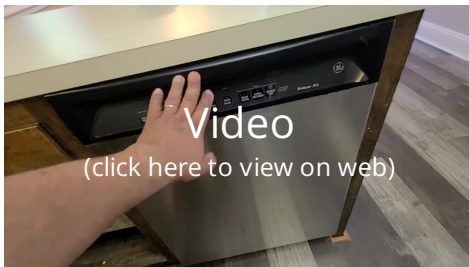
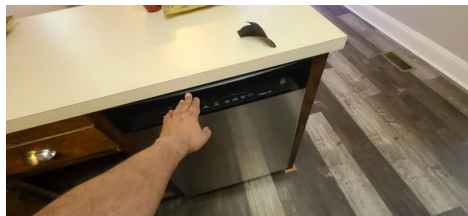
**Defect****NOT SECURED**

The dishwasher was not secured to the countertop or cabinet and would move. This could allow damage to the dishwasher, its wiring or its plumbing. The dishwasher needs to be repaired by a qualified contractor.

Contact a qualified plumbing contractor.

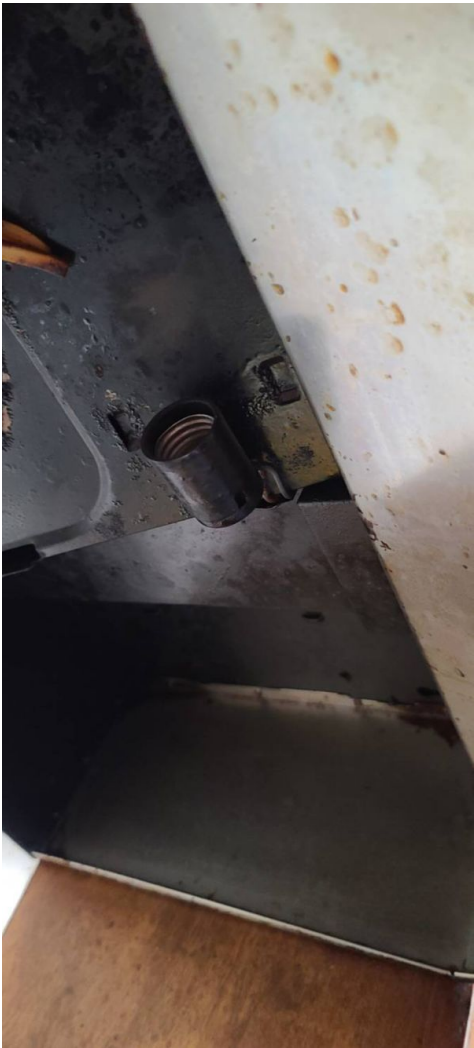
LIGHT NOT WORK

The work light on the bottom of the range hood did not work properly. Thus, it will be difficult to see items on the range/cooktop. The light needs to be repaired by a qualified contractor.

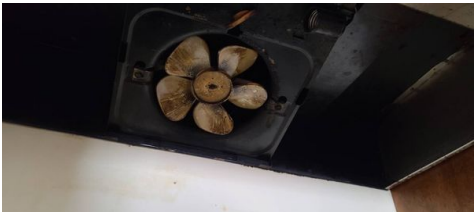
The grease screen(s) were not installed on the range hood. The grease screen(s) keep grease/debris out of the exhaust fan. The range hood needs to be repaired by a qualified contractor.

Recommended DIY Project

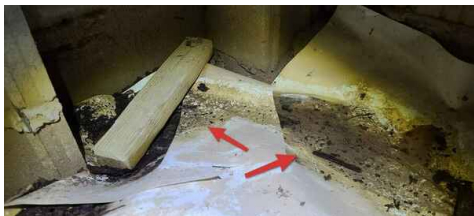
Under Front steps

There was standing water in the location(s) listed above of the crawl space. The standing water indicates the crawl space is not graded properly to allow the water to drain away and can create an unhealthy environment. There was a foundation drain system excavated into the crawl space. The source of the water was unknown. The source of the water needs to be determined and repaired by a qualified contractor. The crawl space grading needs to be repaired by a qualified contractor so the water drains out.

Contact a foundation contractor.

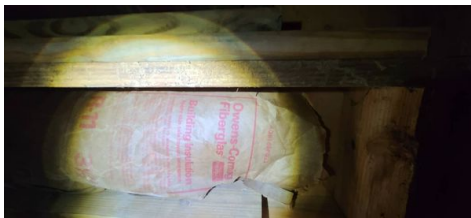
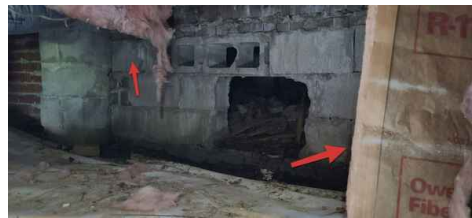
There was missing/falling/dangling batt insulation in the crawl space, which can allow heat transfer through the floor. The insulation is supposed to be installed against the conditioned surface, i.e. the subflooring. The crawl space insulation needs to be repaired by a qualified contractor.

Falling insulation near front steps
